TRUTH OR CONSEQUENCES, NM

MULTIMODAL TRANSPORTATION SAFETY PLAN

2021

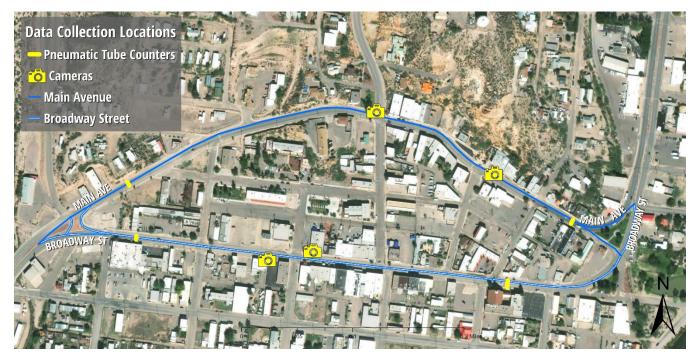
Figure 5: Video Camera and pneumatic tube deployments in Focus Area 1.

The project team conducted pneumatic tube counts and collected video data to quantify the multimodal traffic activity in Focus Area 1 between February 18, 2021, and February 21, 2021. Pneumatic tube counters yielded motor vehicle classifications, volumes, and speeds. Pneumatic tube counters were deployed on Main Avenue near S. Pershing and McAdoo Streets and N. Broadway Street near S. Pershing and Post Streets. In addition, video data were collected at two locations on Main Avenue and two locations on N. Broadway Street. The video cameras and pneumatic tubes were deployed at the locations shown in Figure 5. The cameras provided insight into pedestrian and bicycle activity in the focus area.

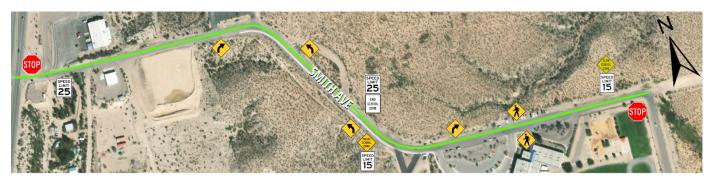
Figure 19: Traffic Sign Inventory, Smith Ave.

The project team also visited Focus Area 2 during the site visits in March 2021. The Smith Avenue and Silver Street corridors provide access to T or C Elementary School from N. Date Street and E. 9th Street. These corridors also offer access to Sierra Vista Hospital and Sierra Health Care. The paved roadways are 26-feet wide and unmarked. The speed limit on Smith Avenue is 25 MPH for eastbound motorists entering from N. Date Street. The 25 MPH speed limit continues for approximately 2,000 feet until the school zone begins, and the speed limit reduces to 15 MPH. A 15 MPH speed zone continues Silver and N. Silver Streets until E. 9th Avenue. When motorists enter Focus Area 2 from the south, the speed limit on Silver Street is 25 MPH. Approximately 1,000 feet from the intersection at E. 9th Avenue, a school zone begins, and the speed limit reduces to 15 MPH. The school zone continues around the school property on N. Silver Street and Smith Avenue until it ends approximately 1,000 feet from the intersection at N. Date Street. Motorists encounter a stop sign at N. Date Street when traveling west on Smith Avenue. Likewise, motorists traveling south on Silver Street come to a two-way stop-controlled intersection at E. 9th Street. An all-way stop-controlled intersection is present at N. Silver and Silver Streets northeast of the school's property. Pedestrian infrastructure is minimal in Focus Area 2, with approximately 1,000 feet of sidewalk on the south side of Smith Avenue just due west of the school.

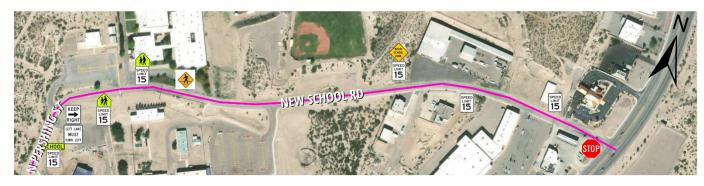
Figure 29: Traffic Sign Inventory, New School Rd.

Focus Area 3 is New School Road west of N. Date Street to N. Pershing Street and N. Pershing Street from New School Road to Marie Street. These corridors also provide access to Hot Springs High School and T or C Middle School. The paved asphalt on New School Road and N. Pershing Street is 36-feet wide between N. Date Street, the southernmost driveway of Hot Springs High School. From there until Barton Street, the asphalt roadway narrows to 32-feet. Between Barton and Marie Streets, the roadway is 44-feet wide. Lane markings exist at N. Date Street, at the eastern parking lot driveway of Hot Springs High School, and the western parking lot driveway of T or C Middle School. Marked crosswalks exist on New School Road between T or C Middle School and Hot Springs High School.

A 15 MPH school zone begins on New School Road, 1,000 feet from N. Date Street, extending approximately 3,000 feet, ending on N. Pershing Road a hundred feet before Barton Street. Motorists encounter a stop sign at N. Date Street when traveling east on New School Road. Likewise, southbound motorists on N. Pershing encounter an all-way stop at Barton Street and a two-way stop approaching Marie Street. Similar to Focus Area 2, pedestrian infrastructure is minimal, with approximately 1,400 feet of sidewalk on the south side of New School Road between N. Date Street and the eastern driveway of Hot Springs High School.

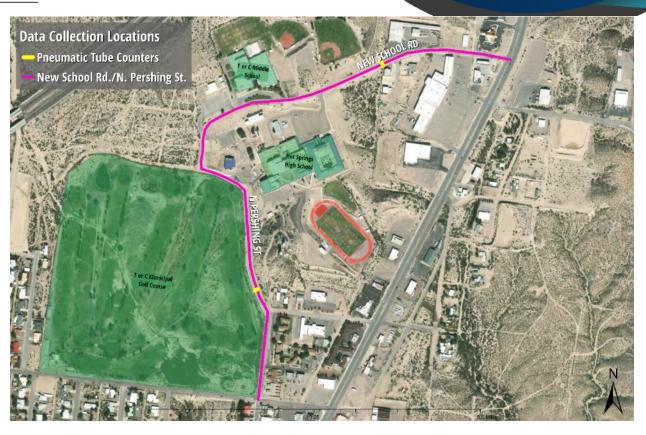
Figure 31: Pneumatic tube deployments in Focus Area 3.

Pneumatic tube data collected between February 18, 2021, and February 21, 2021, quantified motorist traffic activity in Focus Area 3. A pneumatic tube counter was deployed on New School Road east of T or C Middle School and Hot Springs High School. Another tube counter collected traffic data on N. Pershing Street north of Barton Street. The posted speed limit in these areas is 15 MPH. The pneumatic tubes were deployed at the locations shown in Figure 31

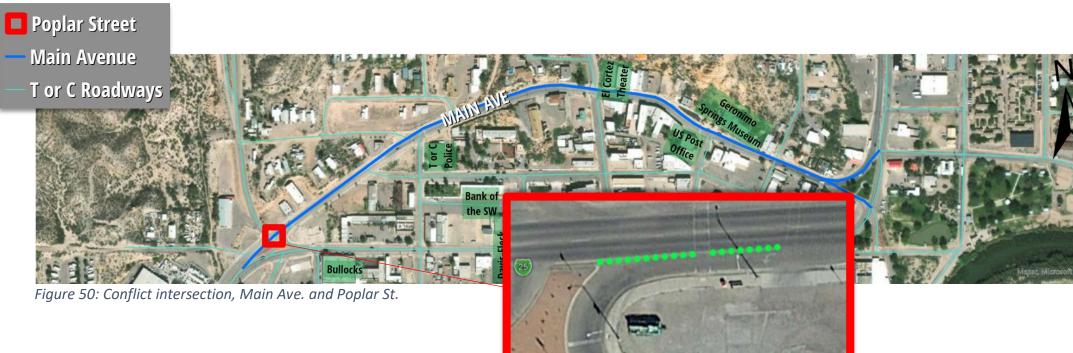
Figure 49: Recommend bollard installation.

The City of T or C identified Poplar Street and Main Avenue as a conflict intersection. Southbound motorists on Poplar Street desiring to travel east on N. Broadway Street regularly cut through the private property on the northeast corner of the intersection. By doing so, motorists access the Post Street turn just before Main Avenue merges with N. Broadway Street. This maneuver is a safety concern because pedestrian traffic regularly uses this area to access Bullocks supermarket on the corner of N. Broadway and Post Streets. The safety plan recommends installing bollards on the left turn lane providing access to N. Broadway Street from Main Avenue to discourage the unsafe vehicular maneuver.

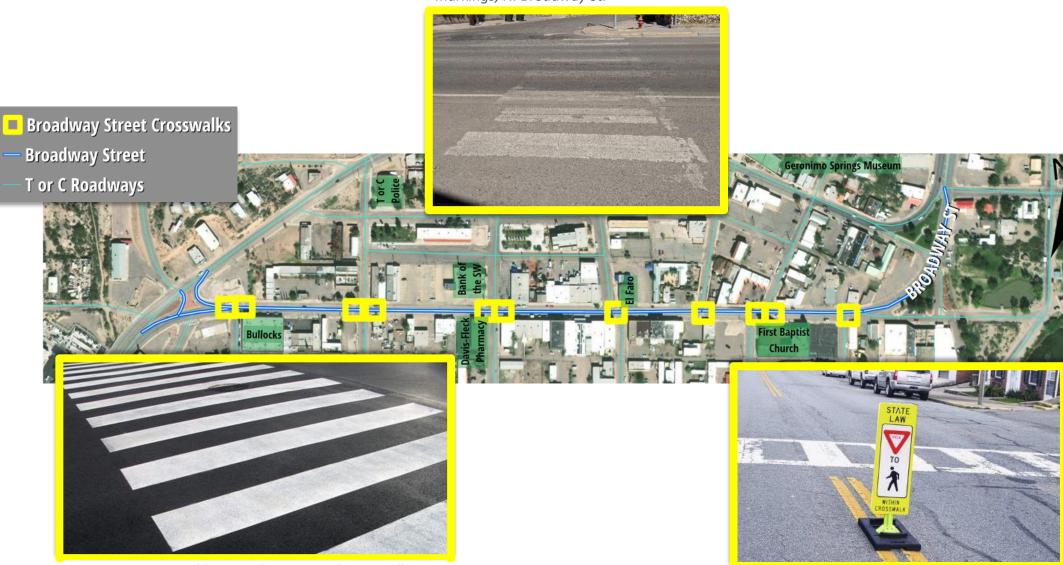
Figure 57: Freshly striped continental crosswalk.

Pedestrian activity is at its highest on N. Broadway Street in Focus Area 1. As such, this safety plan recommends refreshing the striping of the marked crosswalks, as shown Figure 57, in this section as a Tier 1 countermeasure. Figure 56 shows an example of the condition of the existing crosswalk markings. The image on the bottom right shows an in-street pedestrian sign that creates a vertical presence for drivers to alert them to yield for pedestrians. This plan recommends installing in-street pedestrian signs on the centerline and edge lines of the driving lanes. Studies show that these combined treatments have high compliance rates for yielding/stopping for pedestrians and encouraging reduced motor vehicle speeds¹⁰.

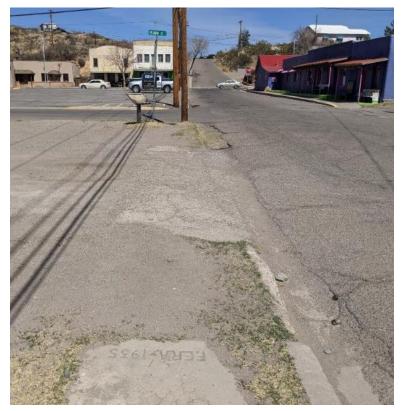
Figure 64: Existing conditions of pedestrian infrastructure in downtown T or C on city owned streets.

Several community initiatives emerged in Focus Area 1. First, the recommended safety countermeasures apply to Main Avenue and N. Broadway Street, facilities maintained by NMDOT. However, pedestrian facilities, like that shown in Figure 64 on S. Pershing, Jones, Foch, Sims, McAdoo, Daniels, and Clancy Streets are overlooked regarding maintenance. Where sidewalks exist, they pose a safety challenge for any pedestrian, are not comfortable to use, and do not adhere to ADA standards. This plan recommends pedestrian facility maintenance and improvements to enhance safety throughout Downtown T or C.

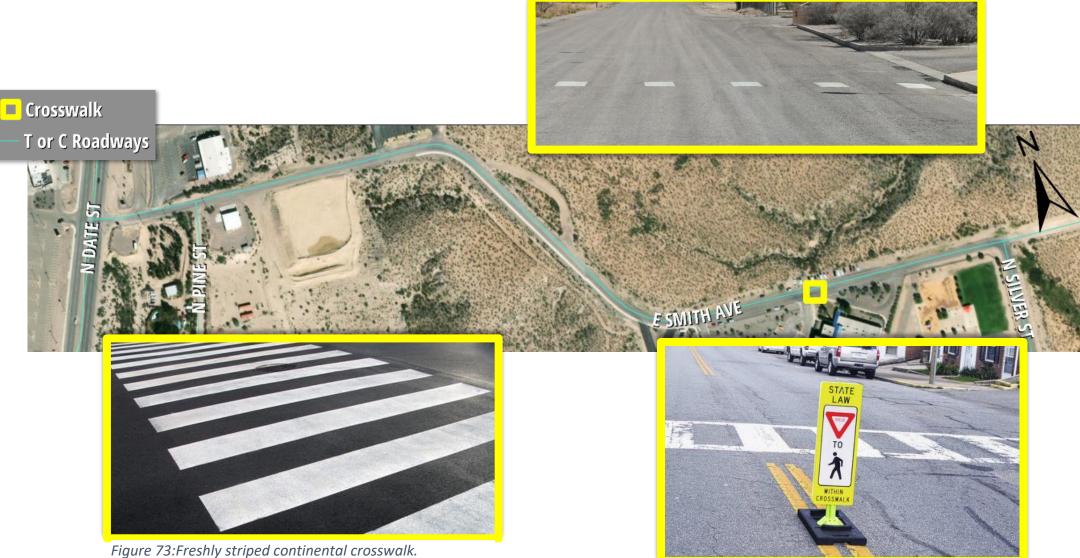
Figure 72: Existing conditions of crosswalk markings, Smith Ave.

Pedestrian safety and accessibility are of utmost importance in Focus Area 2 due to the likelihood of children walking through this corridor. The safety plan recommends refreshing the striping of the marked crosswalk as a Tier 1 countermeasure. Figure 72 is an example of the condition of the existing crosswalk marking. Figure 74 shows an in-street pedestrian sign that creates a vertical presence for drivers to alert them to yield for pedestrians. This plan recommends installing in-street pedestrian signs on the centerline and edge lines of the driving lanes in each direction of travel. Studies show that these combined treatments have high compliance rates for yielding/stopping for pedestrians and encouraging reduced motor vehicle speeds¹¹.

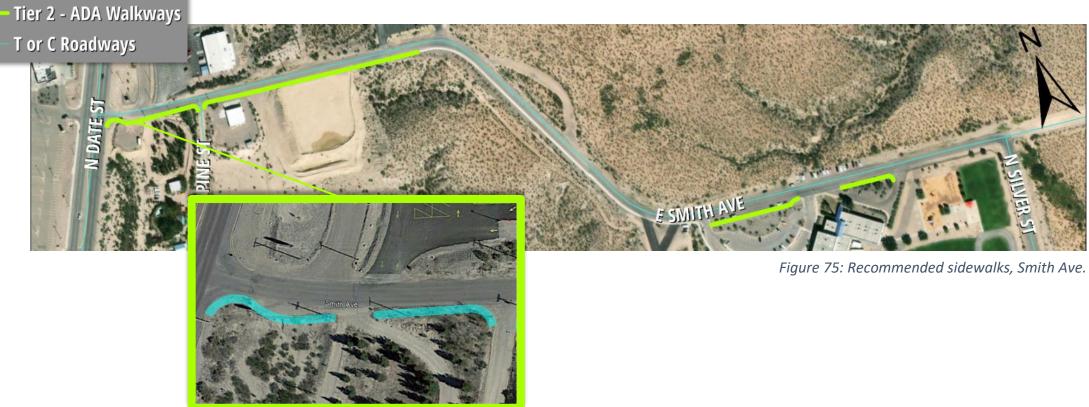
Figure 76: Detail of recommended sidewalk, southeast corner of N. Date St. and Smith Ave.

Figure 75 shows recommended sidewalks in Focus Area 2. This is a Tier 2 countermeasure as it will require multiple funding sources and some design work. The sidewalks would additional provide pedestrian accessibility by filling in the gap from N. Date Street to the existing sidewalk west of T or C Elementary School. This countermeasure will also enhance pedestrian safety by providing a space to walk that is safely out of the way of vehicular traffic.

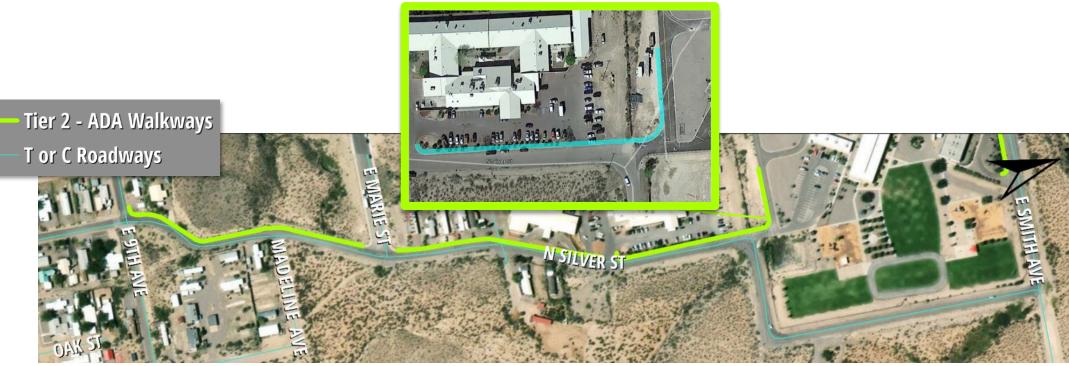
Figure 83: Recommended Tier 2 sidewalks, Silver St.

Figure 83 shows recommended sidewalks on the west side of Silver Street in Focus Area 2. This Tier 2 countermeasure would provide pedestrian accessibility from the residences south of E. 9th Street to the hospital and T or C Elementary School. This countermeasure will also enhance pedestrian safety by providing a space to walk that is safely out of the way of vehicular traffic.

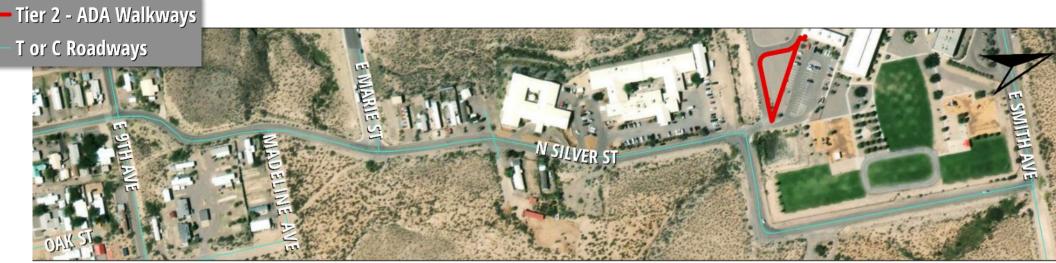
Figure 84: Recommended sidewalks on T or C Elementary School property.

This plan recommends constructing sidewalks on the school's property to ensure pedestrian safety by providing connectivity from the recommended sidewalk on Silver Street. This sidewalk will allow children to access the school from the south side of campus instead of walking along Silver Street, around the sporting fields.

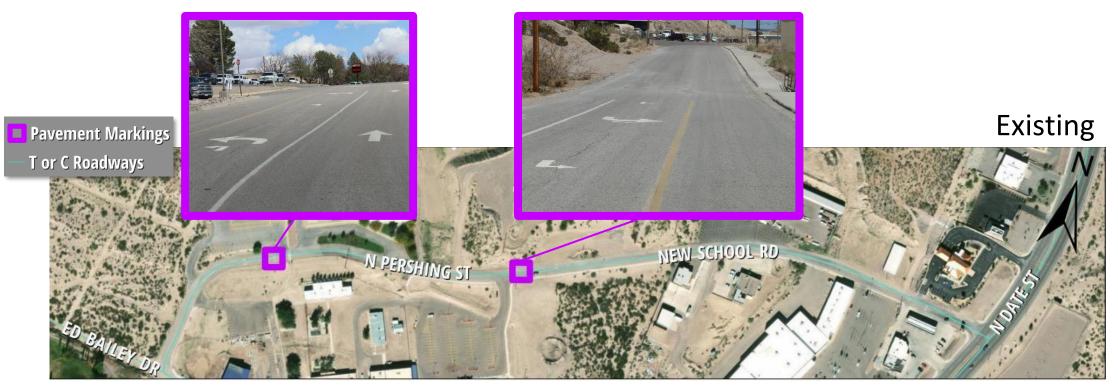
Figure 92: Existing pavement markings, New School Rd.

The existing regulatory speed limit and warning signs on New School Road are shown in Figure 91. In this section, the speed limit is 15 MPH. The first recommendation is to change the speed limit to 25 MPH, update the school speed limit assemblies to indicate 15 MPH on a conditional basis, and install plaques indicating that the 15 MPH speed limit is during specific hours or when children are present, as shown in Figure 90. Additionally, install another 15 MPH speed limit sign augmented with a Dynamic Speed Feedback Sign (DSFS) as motorists approach the schools from the east. Lastly, update the outdated pedestrian warning signs at the crosswalk.

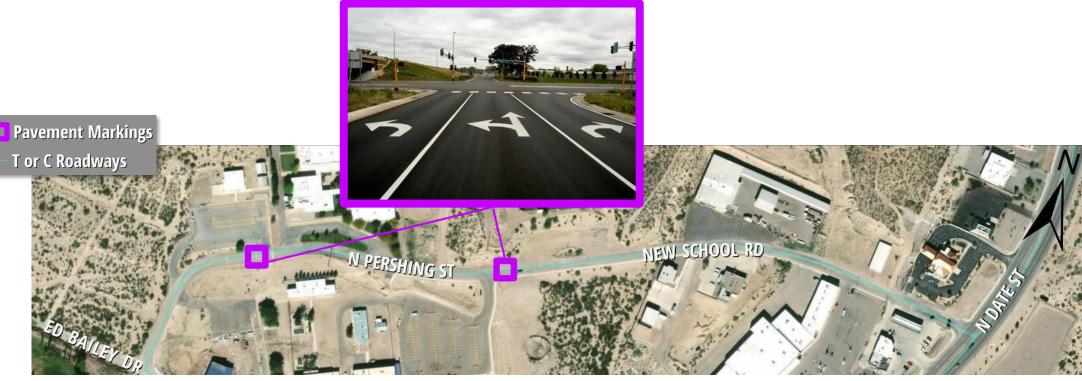
Figure 93: Fresh MUTCD compliant pavement markings.

This plan recommends removing the existing markings and refreshing the roadway communications with MUTCD compliant striping, as shown in Figure 93. This is a Tier 1 countermeasure.

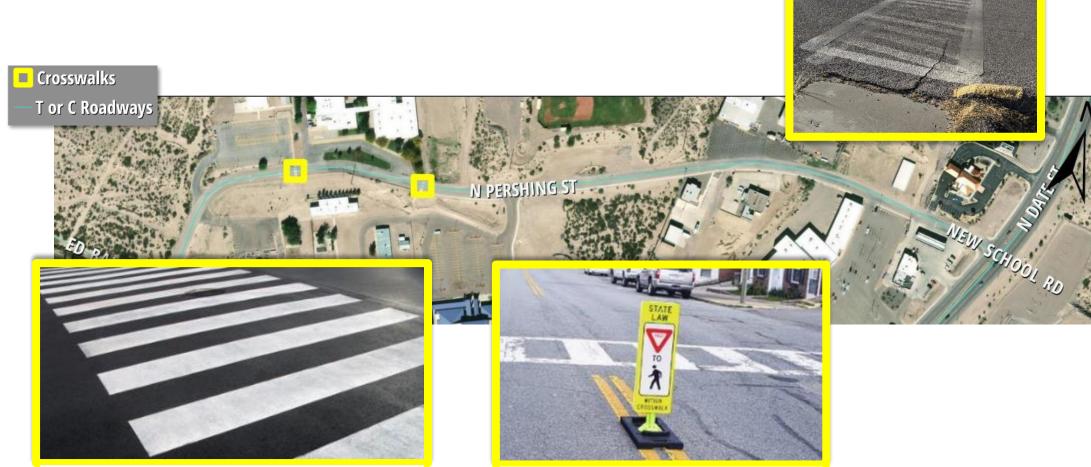
Figure 95: Freshly striped continental crosswalk.

Like Focus Area 2, pedestrian safety and accessibility are of utmost importance due to the likelihood of children walking through this corridor. This safety plan recommends refreshing the striping of the marked crosswalks as a Tier 1 countermeasure. Figure 94 is an example of the condition of the existing crosswalk marking. Figure 96 shows an in-street pedestrian sign that creates a vertical presence for drivers to alert them to yield for pedestrians. This plan recommends installing in-street pedestrian signs on the centerline and edge lines of the driving lanes in each direction of travel. Studies show that these combined treatments have high compliance rates for yielding/stopping for pedestrians and encouraging reduced motor vehicle speeds¹².

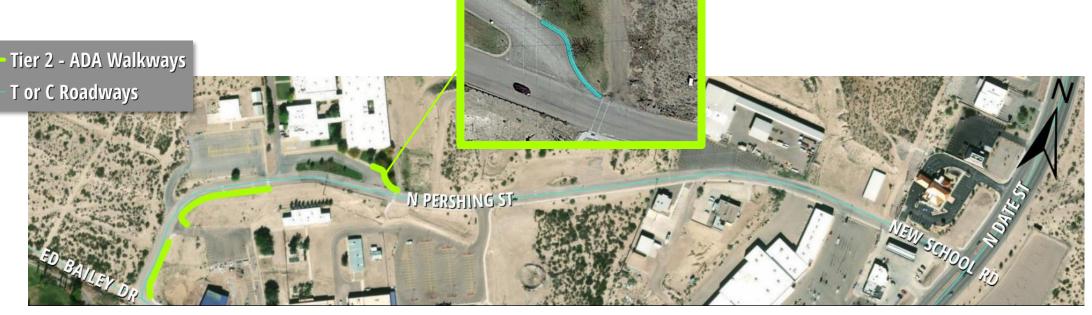
Figure 97: Recommended Tier 2 sidewalks, New School Rd.

Figure 97 shows recommended sidewalks on New School Road in Focus Area 3. This Tier 2 countermeasure provides pedestrian accessibility and connectivity from the eastern crosswalk to T or C Middle School and from the west crosswalk to the existing sidewalk at Hot Springs High School. This countermeasure will also enhance pedestrian safety by providing a space to walk that is safely out of the way of vehicular traffic. This plan recommends constructing ADAcompliant sidewalks on Hot Springs High School's property that provide connectivity from the crosswalks to enhance pedestrian safety further, as shown in Figure 98. ADA accessibility is vital in these locations for accessing the crosswalks because Hot Springs High School is lower in elevation than New School Road.

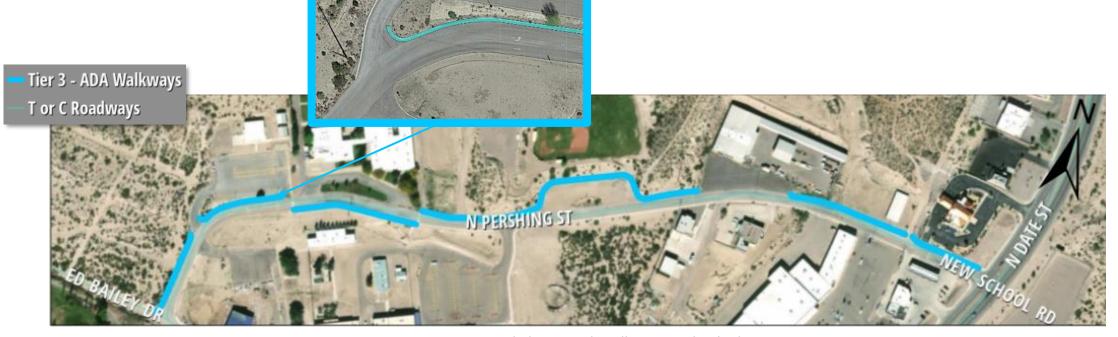
Figure 99: Recommended Tier 3 sidewalks, New School Rd.

Focus Area 3's final recommended countermeasure is to construct sidewalks throughout the New School Road Corridor. This Tier 3 countermeasure will provide a safe space for pedestrians to move through the corridor without sharing the road with motor vehicles.
