US 64 Alignment Study Public Involvement Meeting

# NMDOT Public Involvement Meeting

for the  
US 64 Alignment Study  
from Tres Piedras to Taos, NM

Control No. 5101660

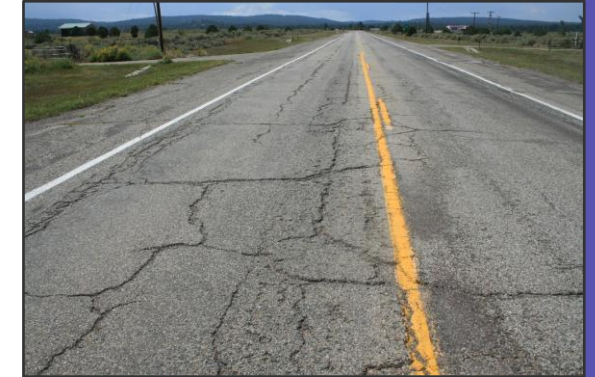
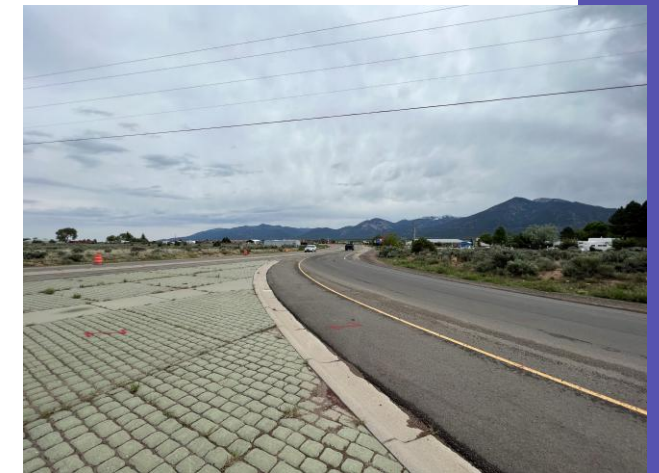
## Existing Roadway/Drainage Deficiencies

- Pavement is in Poor Condition
- Typical Section: 2-12' Lanes
- Inadequate shoulder widths (1')

### ❖ Primary intersections

- Do not meet current geometric design standards
- Inadequate storage capacity (Lt. & Rt.)
- Inadequate Street Lighting

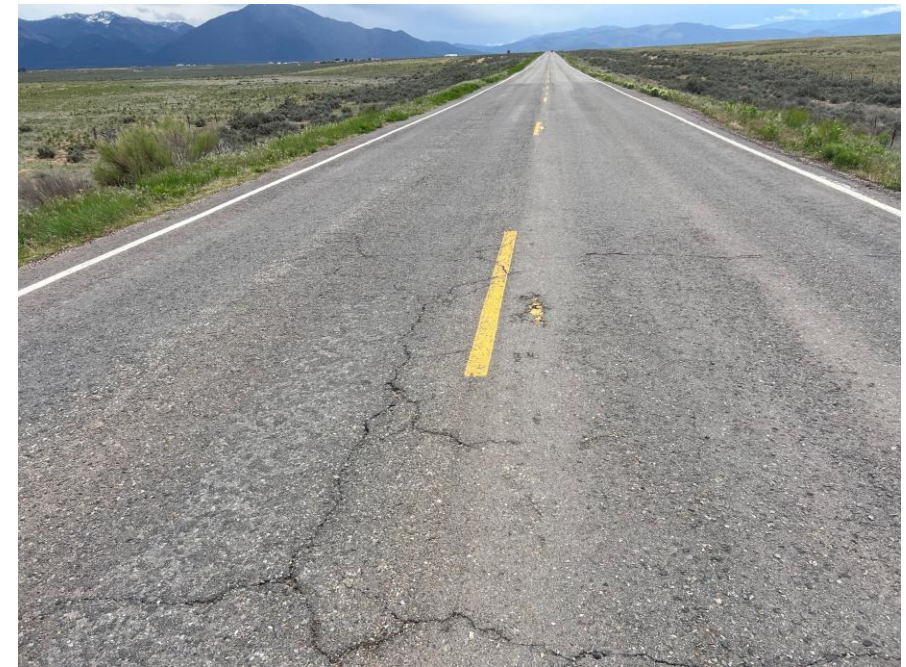
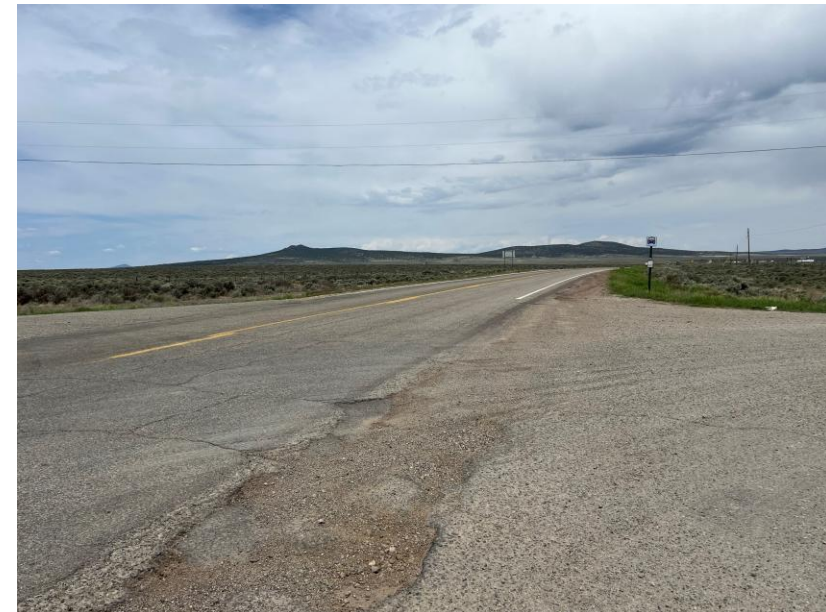
## Existing Intersections and Access Management

- ❖ Intersection Geometry Deficiencies
  - Free Right Turn Lanes do not meet Current Design Standards
  - Pedestrian Access is Inadequate
  - Turn Lane lengths are inadequate and some intersections are lacking turning lanes
  - Inadequate access for businesses
  - Stopped Traffic for Left Turn movements can create Safety Problems and Disrupt Operations
- ❖ Minor Intersections and Driveways
  - No Access Control throughout corridor

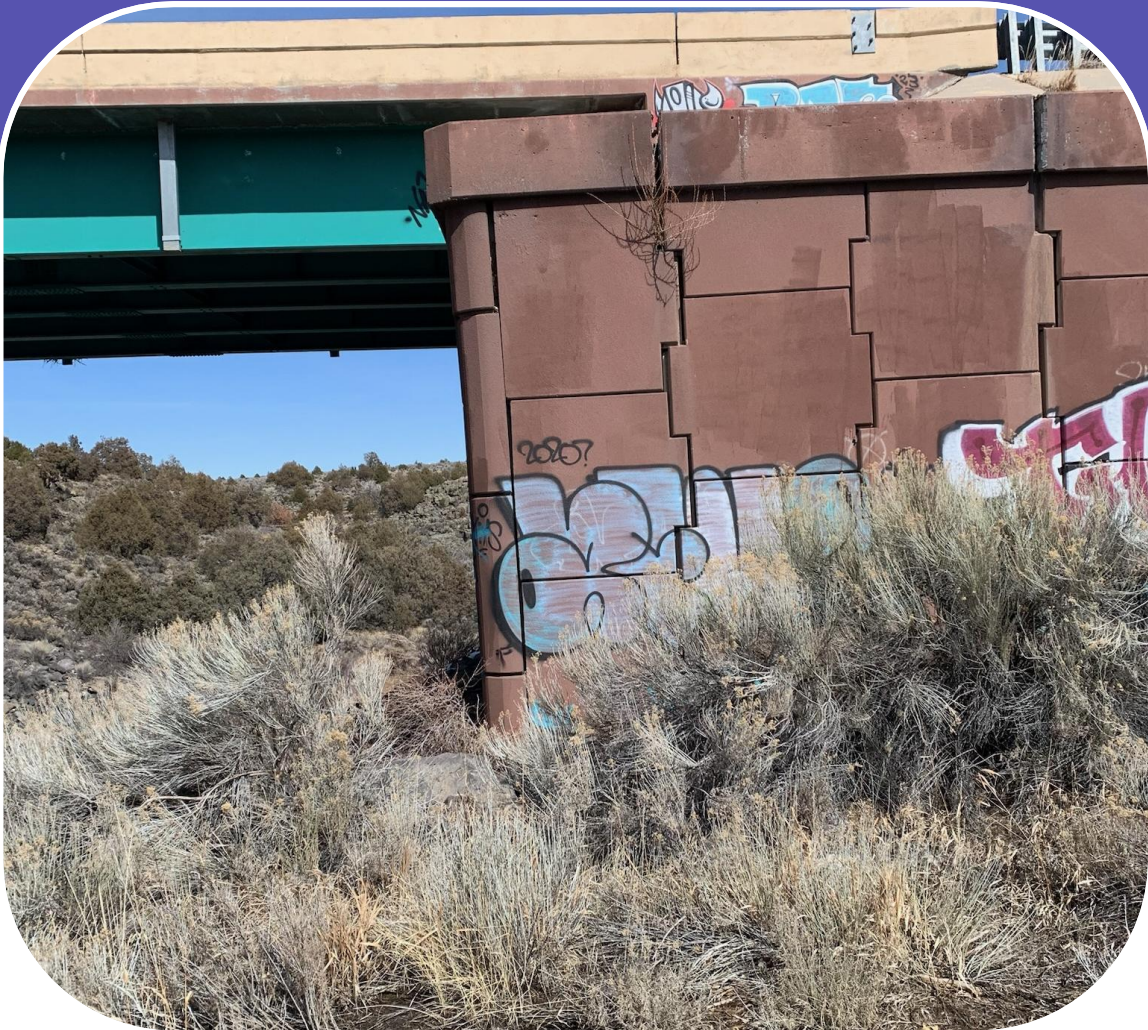
# Bridge 8884 Alternatives

- ❖ Located 0.75 miles east of Tres Piedras at MP 224.25

- ❖ Superstructure (Deck and Girders) are in satisfactory condition
- ❖ Substructure is in Poor condition
- ❖ MSE walls and abutments are moving horizontally towards the superstructure at an accelerated rate
- ❖ Continuing Maintenance costs will be higher than normal

- ❖ Major repair and possible reconstruction of bridge embankment and foundation
- ❖ Repair costs required to stabilize MSE walls and bridge abutments could exceed the cost of full reconstruction.
- ❖ Substructure repairs may result in significant traffic delays during construction

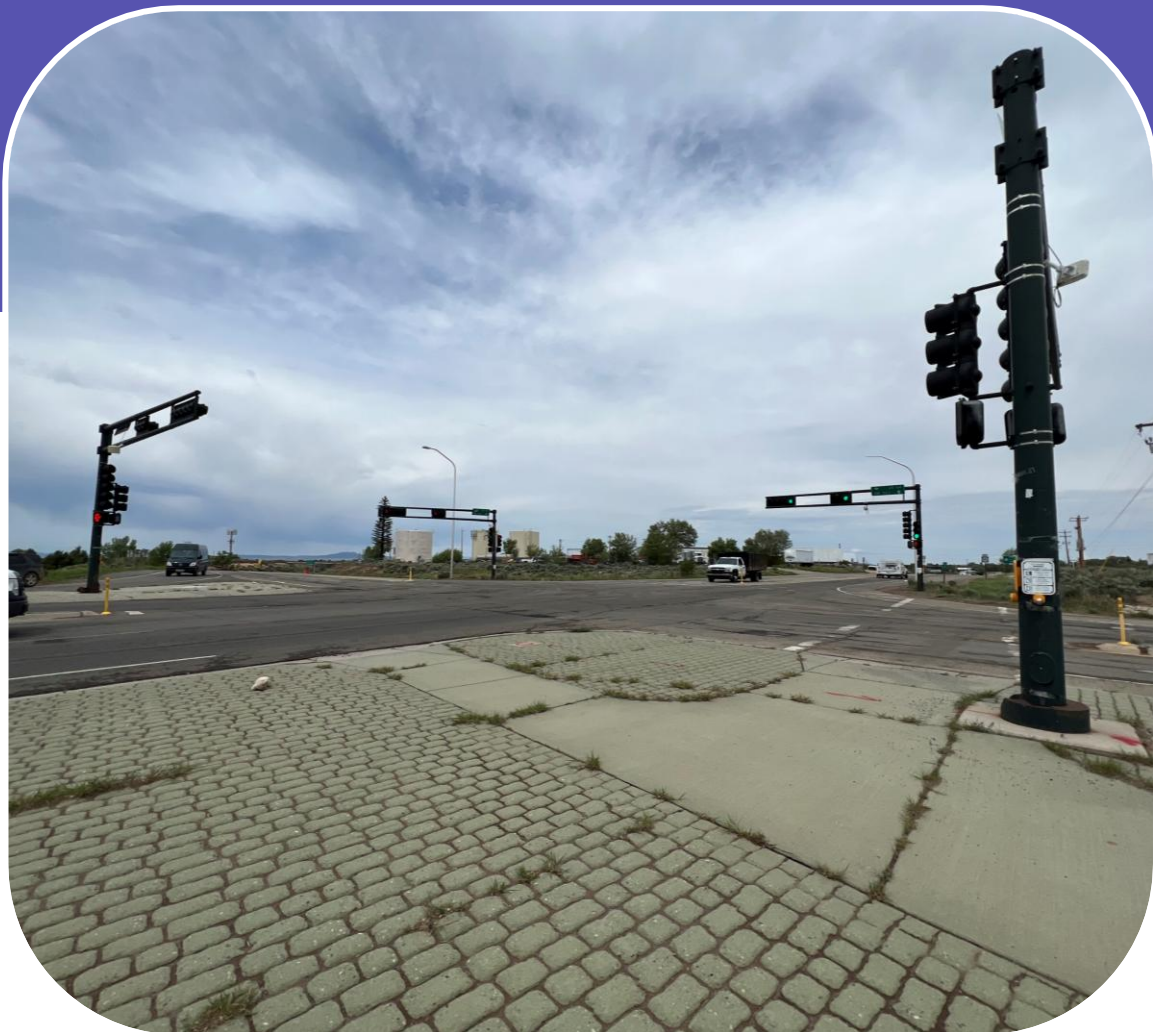
# US 64/US 285 Intersection Alternative 1: No-Build

- US 64/US 285 (flashing beacon) at Beginning of Project
- US 64/ Blueberry Hill Rd. (Stop-controlled)
- US 64/NM 150/NM 522 (signalized)
- 21 other minor intersections

- ❖ No deceleration left-turn lanes on US 64 for entering Blueberry Hill Rd./Taos Gravel Products
- ❖ No facilities for bicyclists or pedestrians
- ❖ Inadequate left and right turn lane lengths
- ❖ Uncontrolled pedestrian crossing at intersection and missing striping

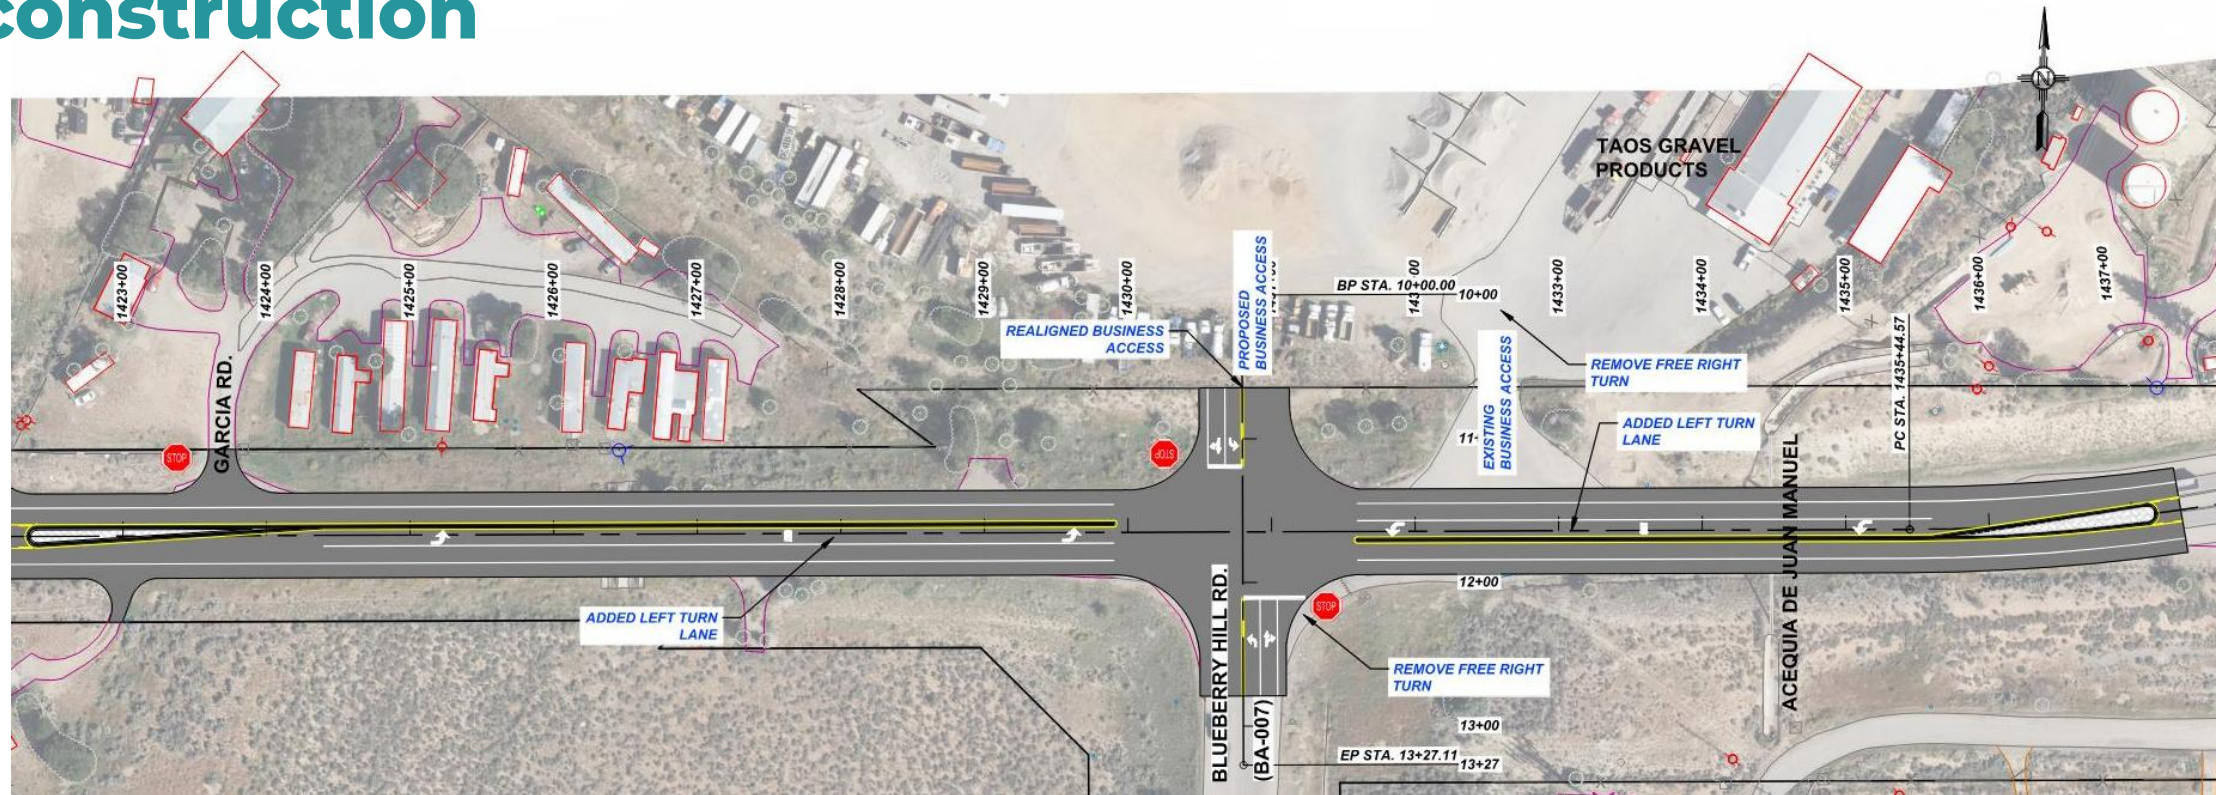
# Blueberry Hill Rd. Intersection Alternative 2: Full Reconstruction

- ❖ Removed free-right turn lane for NB traffic
- ❖ Installed Eastbound and Westbound left turn lanes to meet current standards (SAMM requirements)
- ❖ Realign the business entrance to meet Blueberry Hill Rd. for safer turning movements
- ❖ Update lighting to meet Dark Skies Ordinance
