New Mexico Department of Transportation

NM 264 Phase I and II Services Final Phase I-A/B Report CN 6101220

FINAL PHASE I-A/B REPORT NM 264 FROM THE ARIZONA/NEW MEXICO STATE LINE TO YAH-TA-HEY (MP 0 то MP 16, CN 6101220)

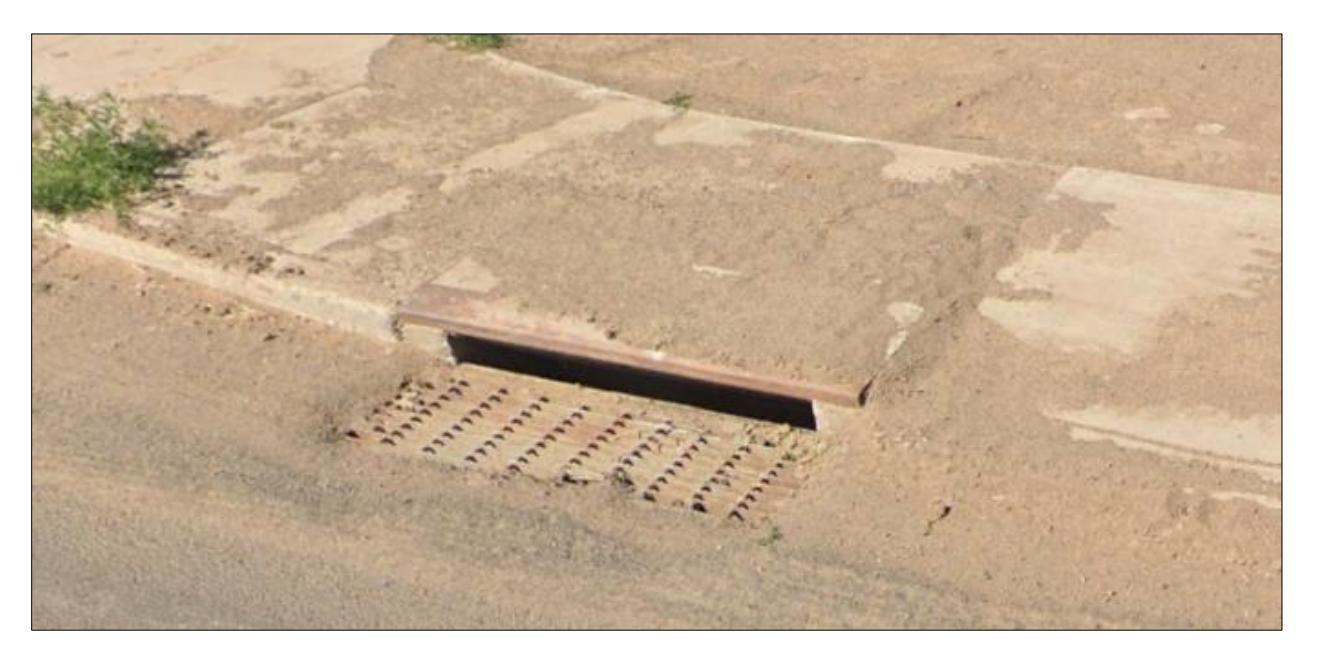
Figure 29. Existing Drainage Inlet

Within Segment 1, the NM 264 alignment bisects the Tse Bonito Valley. The valley is the outfall to several drainages that contribute to the local washes, including Coal Wash, Sand Wash and Tse Bonito Wash, which is immediately south of the alignment. Off-site watersheds generally drain from north to south toward the alignment. Drainage infrastructure within Segment 1 can be classified primarily as on-site roadway drainage control with vertical curb and gutter and combination inlets controlling the spread and depth of water through the street section. Off-site runoff is passed beneath the alignment through a cross culvert located at MP 0.52, which outfalls into Sand Wash. It appears that off-site drainages affect the performance of the on-site drainage infrastructure because of the conveyance of sediment/debris into the street section. Significant deposition of off-site soil can be seen in the existing bus bays located at MP 0.25, at curb inlets, and along the gutter line. The significant deposition of material will reduce the conveyance capacity of both the roadway section and the storm drain located there. Figure 29 shows evidence of off-site sediment being deposited into the street section and ultimately into the storm drain collection system.

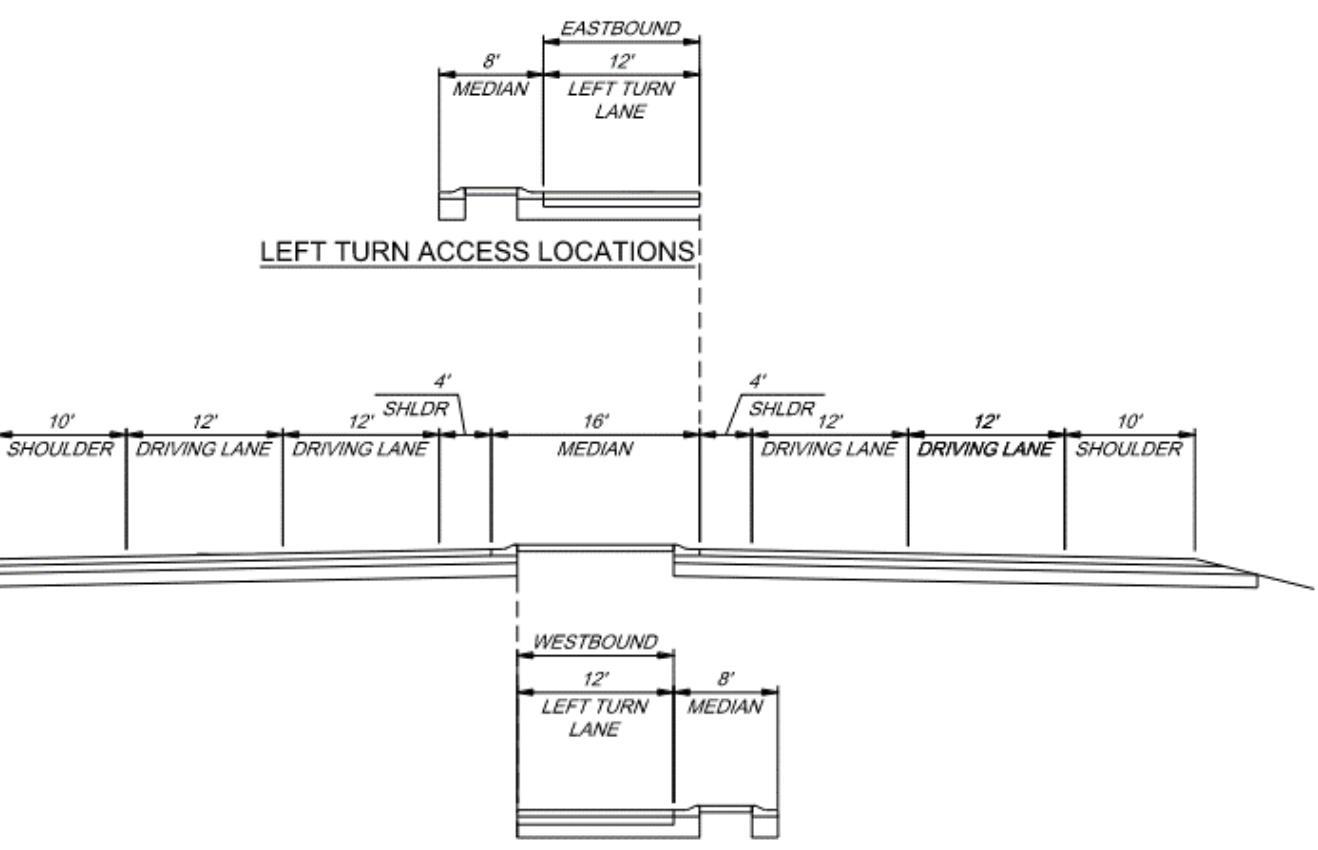
Figure 31. NM 264 Segment 2 Existing Cross-section

Segment 2 is a divided roadway with two 12-foot travel lanes along each direction with a raised median in the middle. This section also has paved inside 4-foot shoulders and outside 10- to 15-foot shoulders with rumble strips (Figure 31).

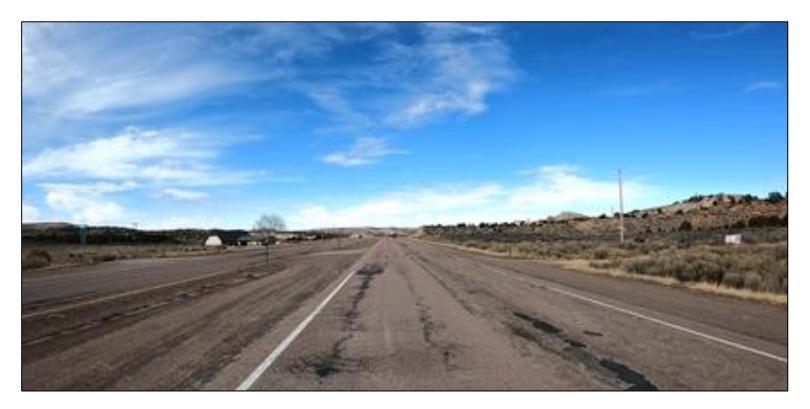
Figure 40. Segment 2 Pavement Condition

A Pavement Condition Assessment Report was completed for NM 264, MP 10 to MP 14, and this section was rated to be "fair." The remainder of the segment has similar visual issues as MP 10 to MP 14, showing evidence of multiple pavement failures such as longitudinal cracking, alligator cracking, and rutting (Figure 40).

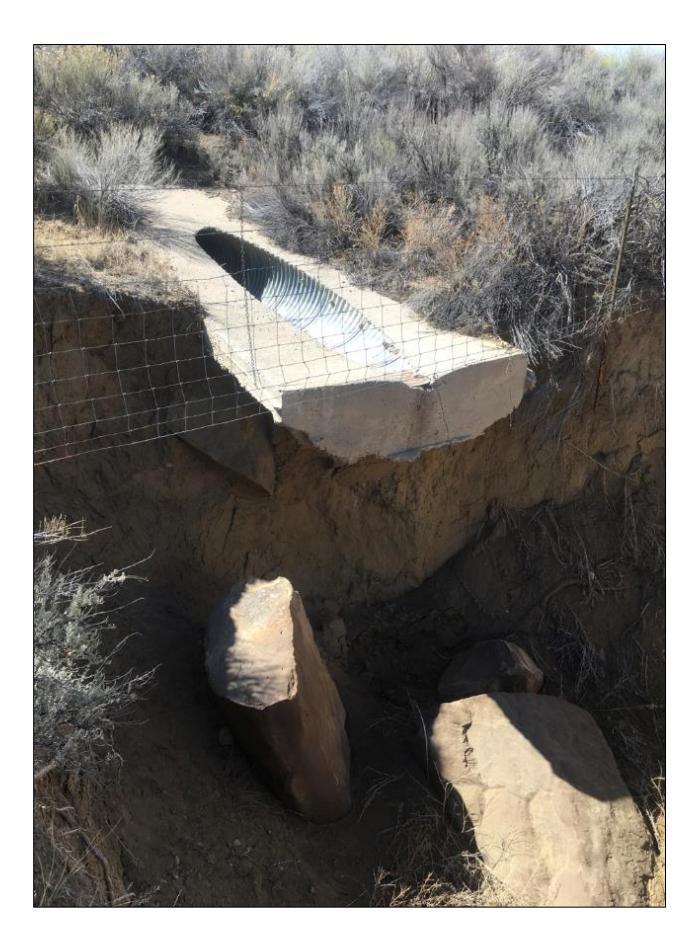
Figure 41. Segment 2 Scour Conditions

Two items became very apparent within the segment. Multiple cross culverts appear close to structural failure because of significant scour and erosion at the outfall. The ability to repair will be limited given the proximity to the existing ROW. The erosion at the outfall appears to be in the form of headcuts that are migrating upstream, resulting in a perched pipe condition that only continues to exacerbate the condition. Figure 41 shows evidence of this kind of condition noted from the field review. Note the significant scour depth (measured as approximately 7 feet) and failure of the slope blanket.

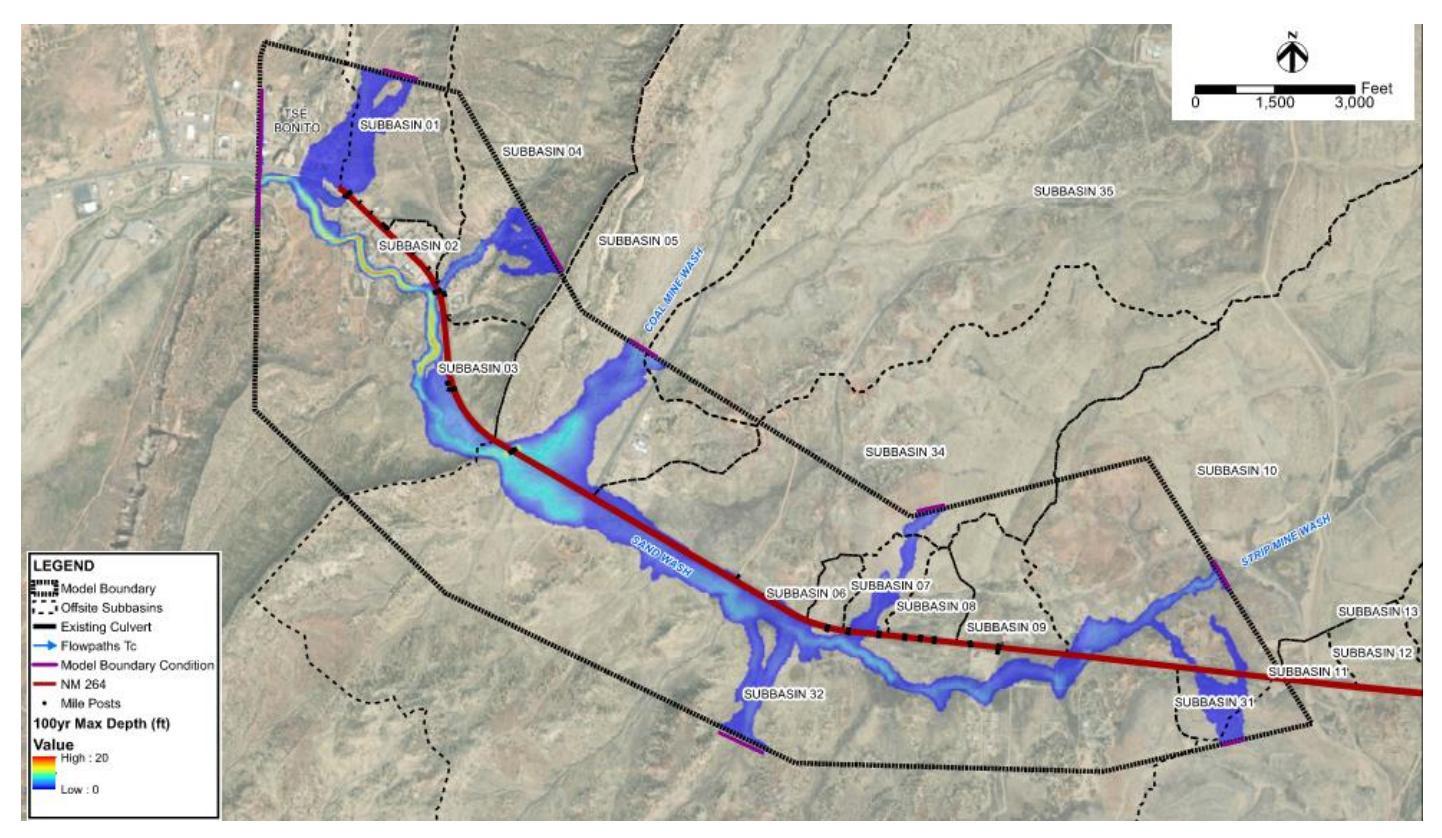
Figure 43. FEMA Floodplain Map

Segment 2 of NM 264 alignment bisects multiple FEMA Zone A effective floodplains. To further understand their characteristics and potential flooding at the NM 264 alignment, a two-dimensional hydraulic model was developed. Coordination with the local floodplain administrator will be conducted to confirm the results and assess local floodplain permitting requirements. As the study progresses, the crossing will be further analyzed with proposed conditions features for a final analysis of the recommended improvements. Figure 43 is a map of the preliminary twodimensional analysis.

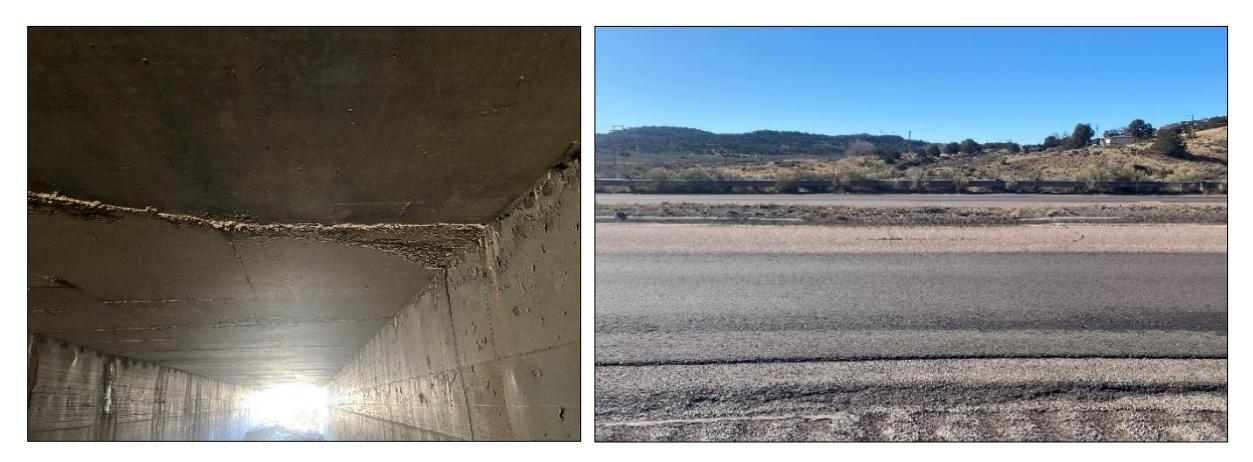
Figure 44. Bridge No. 8741: Midspan Diagonal Crack with Leaching (left) and Low Spot in Roadway Median (right)

The top side of the top slab was unobservable because of the asphalt overlay and the fill material. The underside of the top slab has transverse, longitudinal, and map cracks with leaching and honeycombing. One diagonal crack with heavy leaching was noted at midspan of the box (Figure 44). During a field visit with the NMDOT Bridge Bureau on July 5, 2023, active leaching was observed in a significant portion of the structure. The roadway typical section includes a median with a low point, which has signs of ponding from roadway runoff (Figure 44). The bottom slab was unobservable because of sediment deposition. The box walls have minor vertical, diagonal, horizontal, and map cracks with some minor leaching and honeycombing. There is moderate to heavy leaching in some areas.

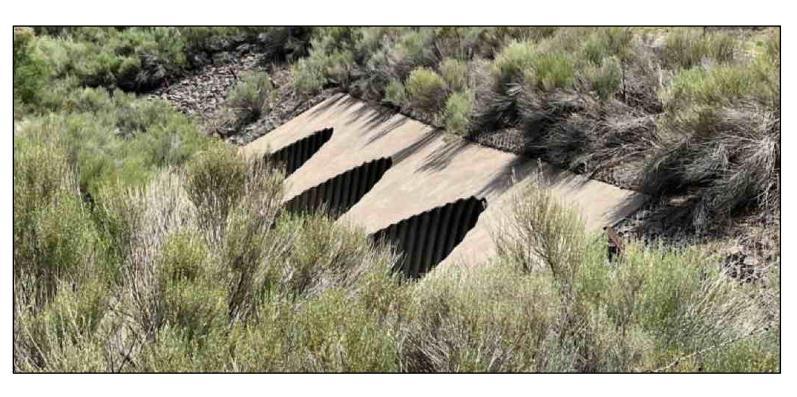
Figure 45. Bridge No. 10017 Inlet

Bridge No. 10017, at MP 3.39, is a three-barrel corrugated metal pipe (CMP) at NM 264 and Tse Bonito Wash (Figure 45).

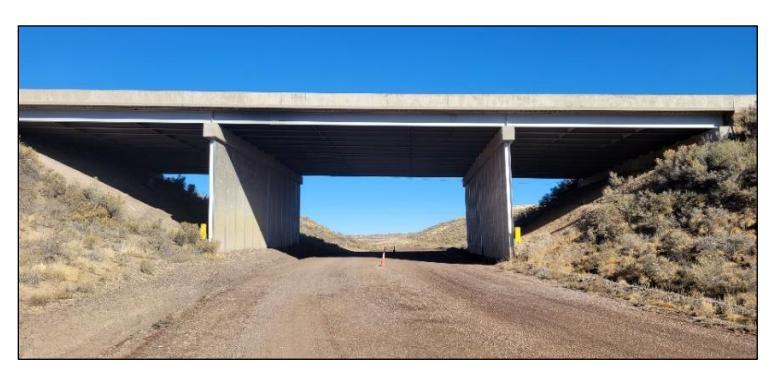
Figure 46. Bridge No. 8626 and No. 8627

They are rolled steel girder bridges with concrete stub abutments and concrete pile caps supported on steel H-piling with concrete web walls.

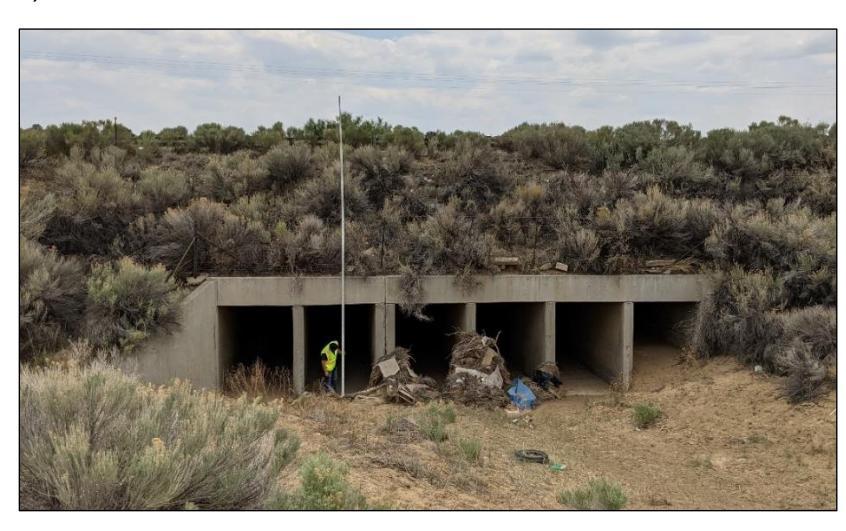
Figure 49. Bridge No. 5381 Inlet

Bridge No. 5381, at MP 13.53, is a six-cell CBC with 6-foot x 8-foot cells at NM 264 and Banana Ridge Wash (Figure 49).

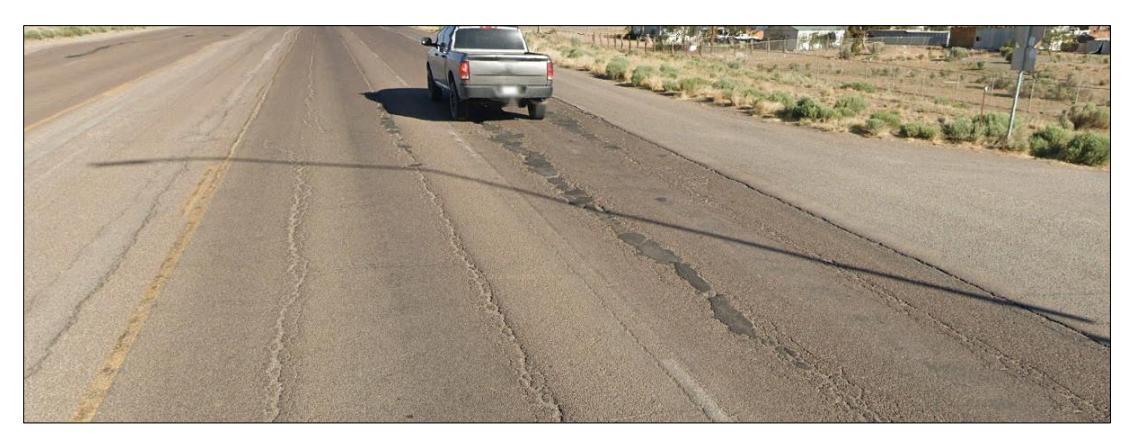
Figure 58. Segment 3 Pavement Condition

The pavement condition in Segment 3 shows evidence of multiple pavement failures, such as longitudinal cracking, alligator cracking, and rutting (Figure 58). A Pavement Condition Assessment Report was performed for NM 264, MP 10 to MP 14, and the section was rated to be "Fair." This segment of the corridor has similar visual issues as MP 10 to MP 14.

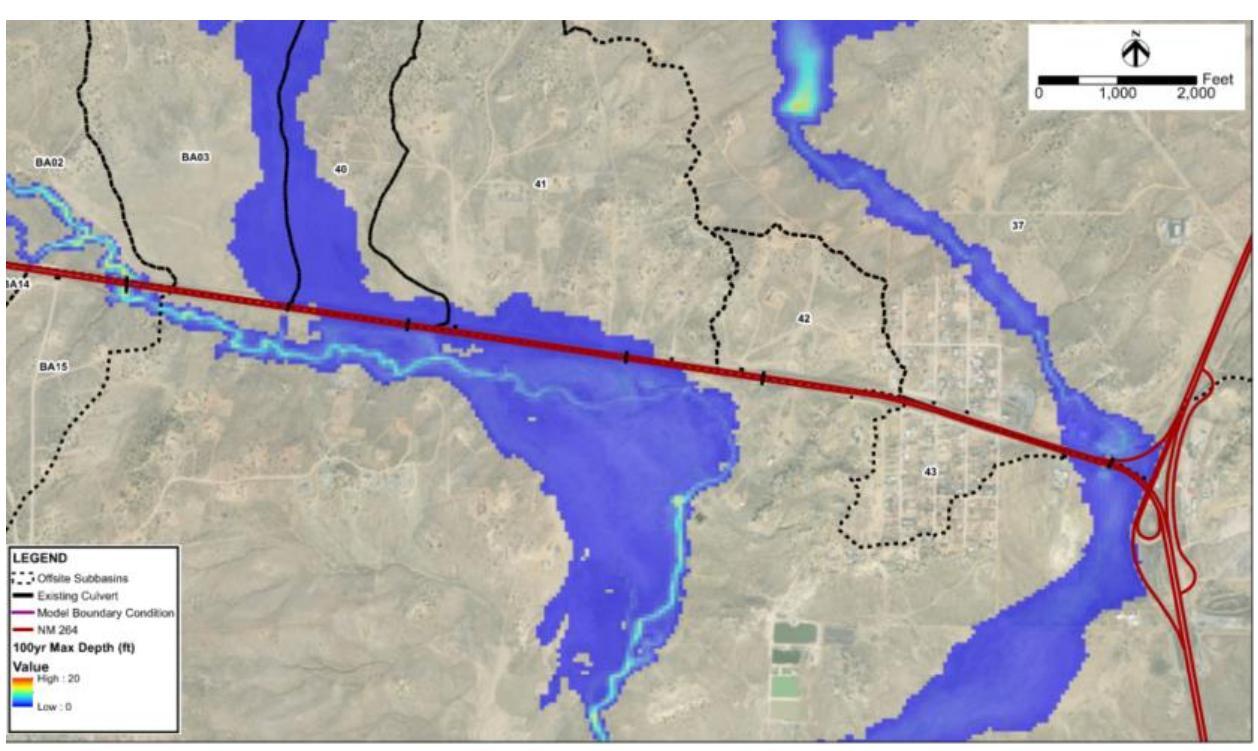
Figure 60. Preliminary SRH2D Floodplain Modeling

However, multiple driveway culverts were noted as filled with sediment and inoperable. In order to properly convey the "breakout" flows the driveway culverts and ditches will need to be replaced and regrading to provide adequate capacity and mitigate the spread of floodwaters along the right of way limits. Preliminary modeling indicates the cross culvert at MP 15.9 has adequate capacity to drain the region, if properly maintained and routinely cleared of debris and sediment.

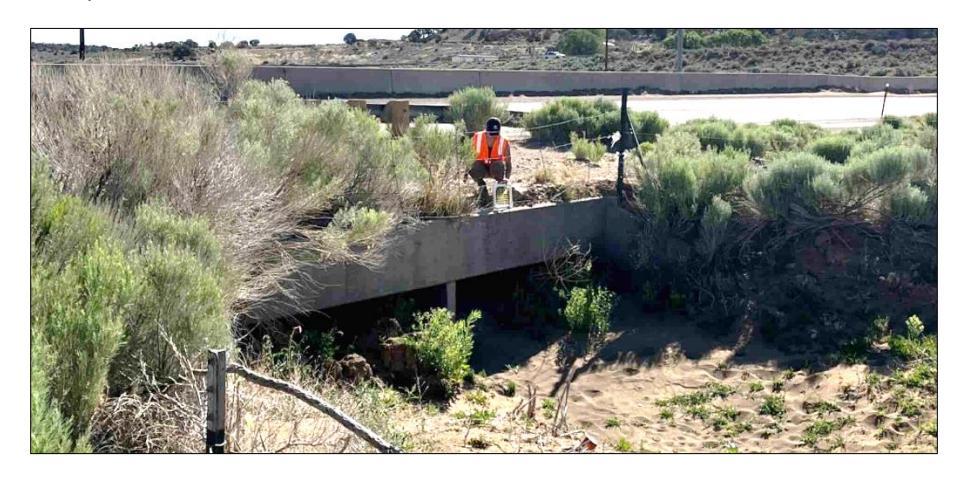
Figure 61. Bridge No. 8703 Outlet

Bridge No. 8703, at MP 15.93, is a two-cell CBC with 10-foot x 5-foot cells at NM 264 and Black Ridge Wash (Figure 61).

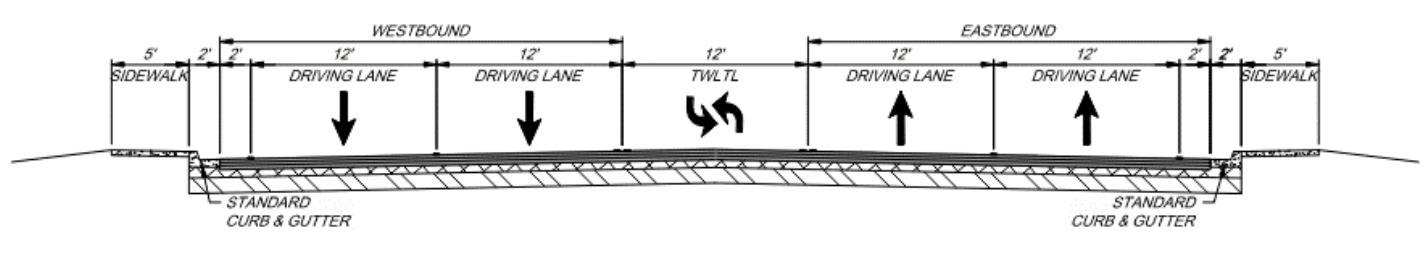
Figure 62. Urban Alternative 1 Existing Typical Section

The No-Build Alternative would make no improvements to the NM 264 urban section. The existing typical section (Figure 62), lane configuration, median details, and pedestrian facilities can be found under Section 1.3, Existing Conditions. See the TNA (Appendix B) for existing traffic safety and operation.

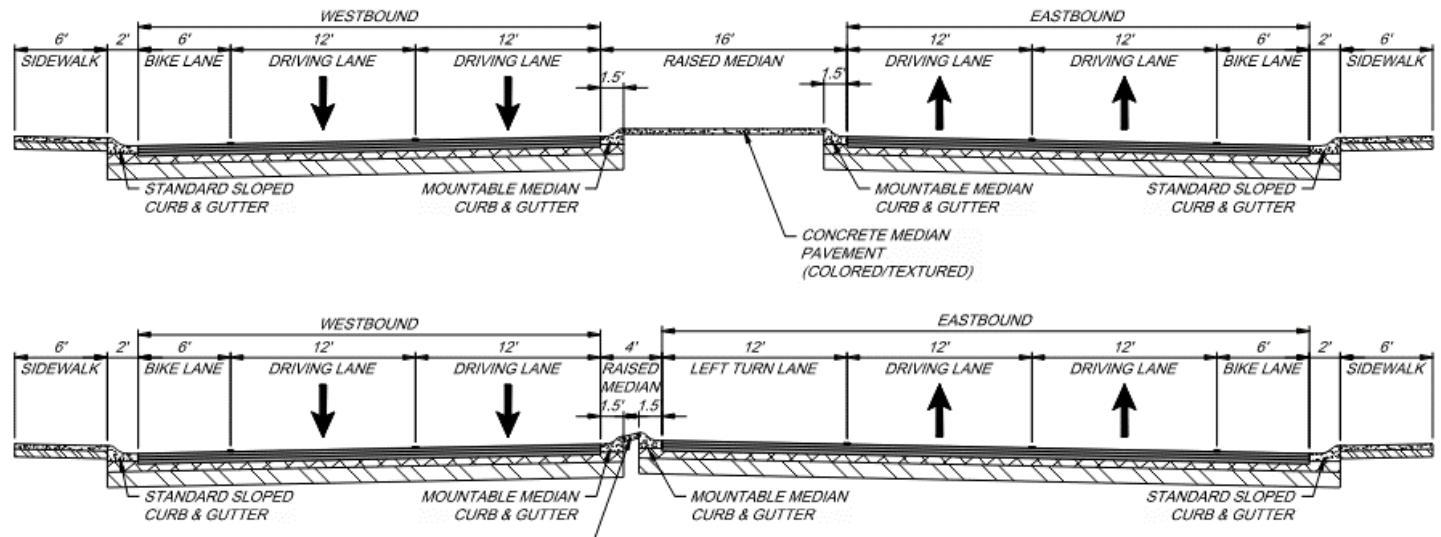
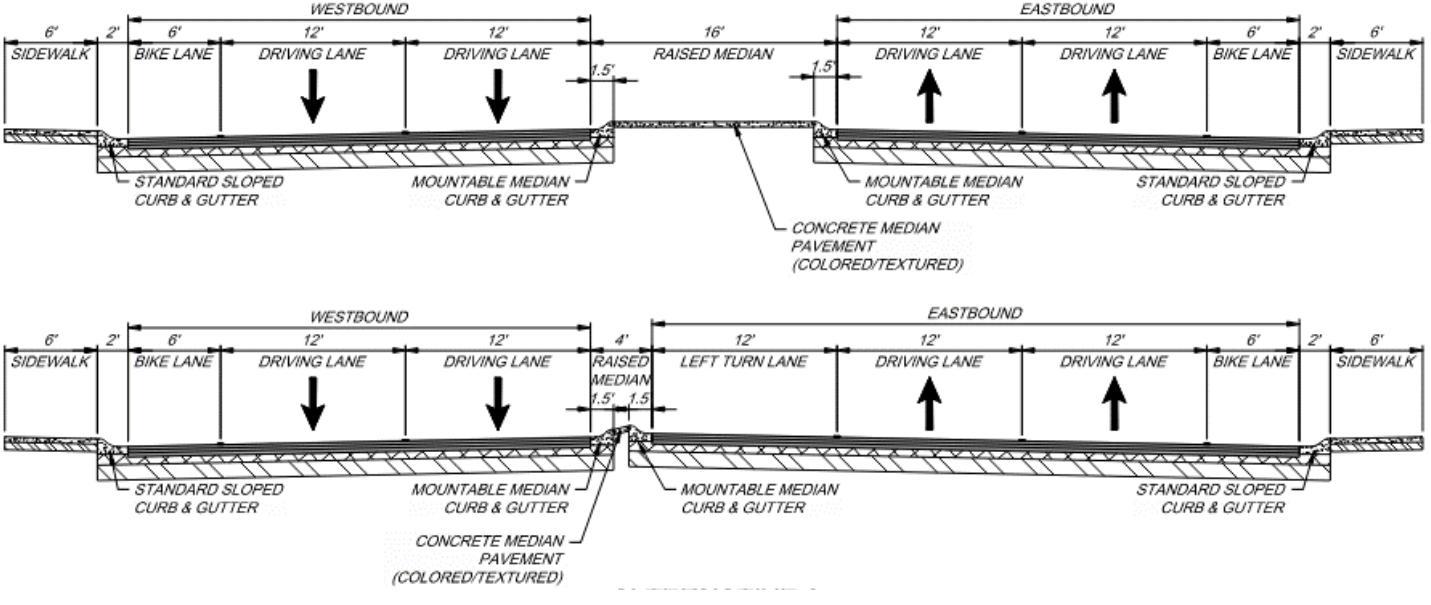
Figure 63. Urban Alternative 2 Typical Section

Urban Alternative 2 would meet the purpose and need for the project. Full reconstruction of the roadway provides the opportunity to address the poor pavement condition and allows for improvement of the roadway drainage. Additionally, it allows for the project to provide upgraded pedestrian facilities to meet ADA/PROWAG requirements, as well as bicycle facilities for the project and managed access to improve the safety of the roadway.

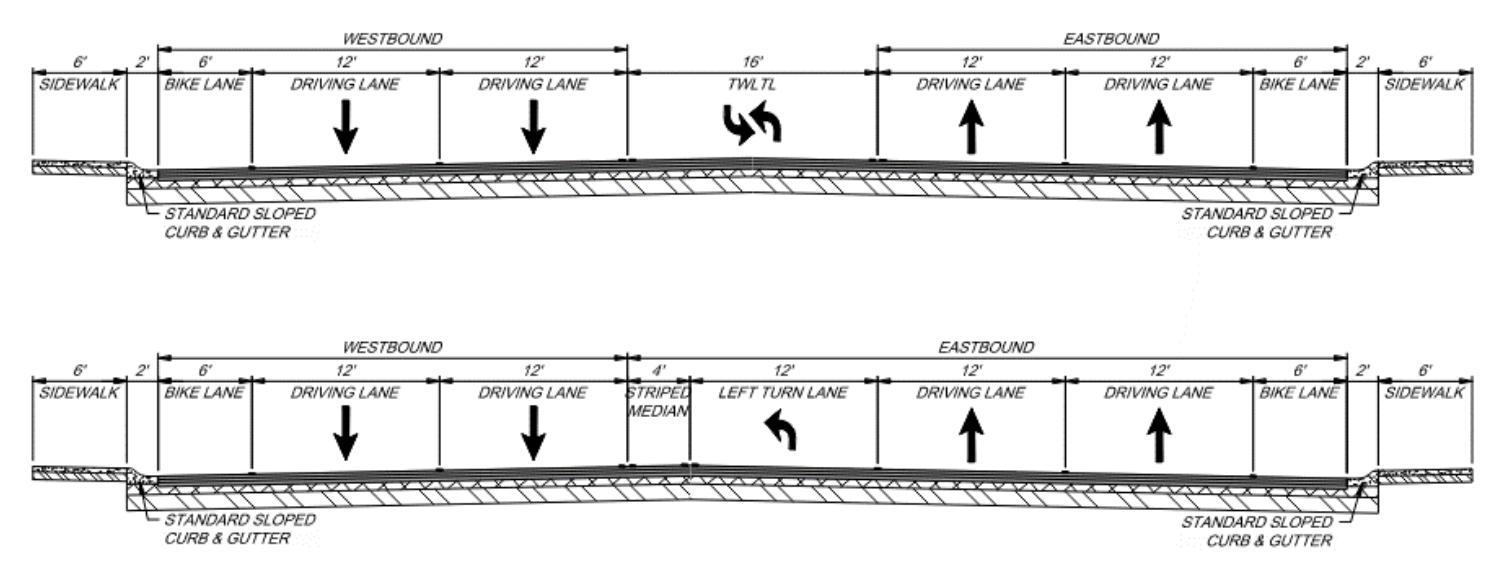
Figure 65. Urban Alternative 3 Typical Section

Urban Alternative 3 includes reconstruction of the full 4-lane roadway section. The newly constructed section would include two 12-foot driving lanes in each direction, a 16-foot TWLTL, and 6-foot bike lanes in each direction (Figure 65). There is an option for the bike lanes to be separated from the travel lanes with a buffer by reducing the travel lanes to 11 feet wide, which may improve bicyclist safety and provide traffic-calming benefits. There would be mountable curb and gutter on the outside of the section in each direction with a 6-foot sidewalk. Other improvements include updated signing and striping with left-turn lanes provided to adjacent properties. Signal timing along the segment would also be improved to accommodate the more elderly population in the area by providing increased walk times to cross the street at signalized intersections.

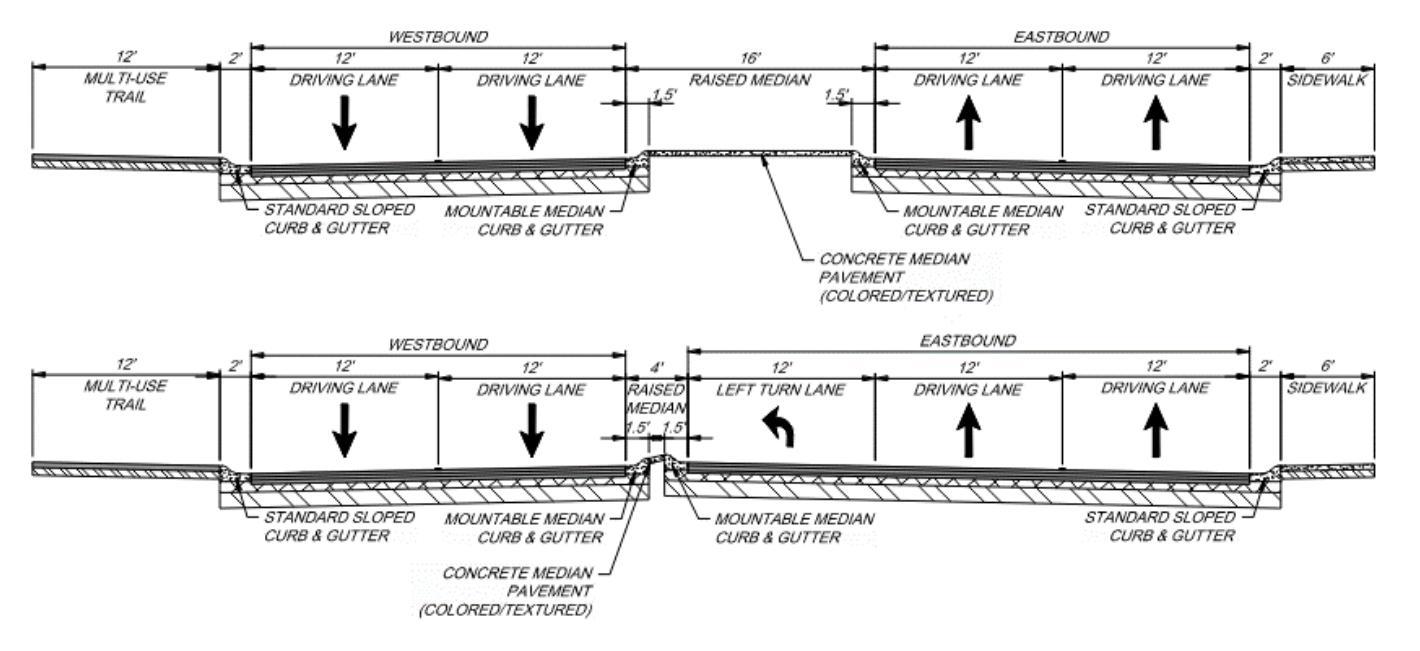
Figure 66. Urban Alternative 4 Typical Section

Urban Alternative 4 includes reconstruction of the full 4-lane roadway section. The newly constructed section would include two 12-foot driving lanes in each direction and a 16-foot raised mountable curb median (Figure 66). There would be mountable curb and gutter on the outside of the section in each direction with a 6-foot sidewalk in one direction and a 12-foot multi-use trail in the other. Other improvements include updated signing and striping with left-turn lanes provided to adjacent properties.

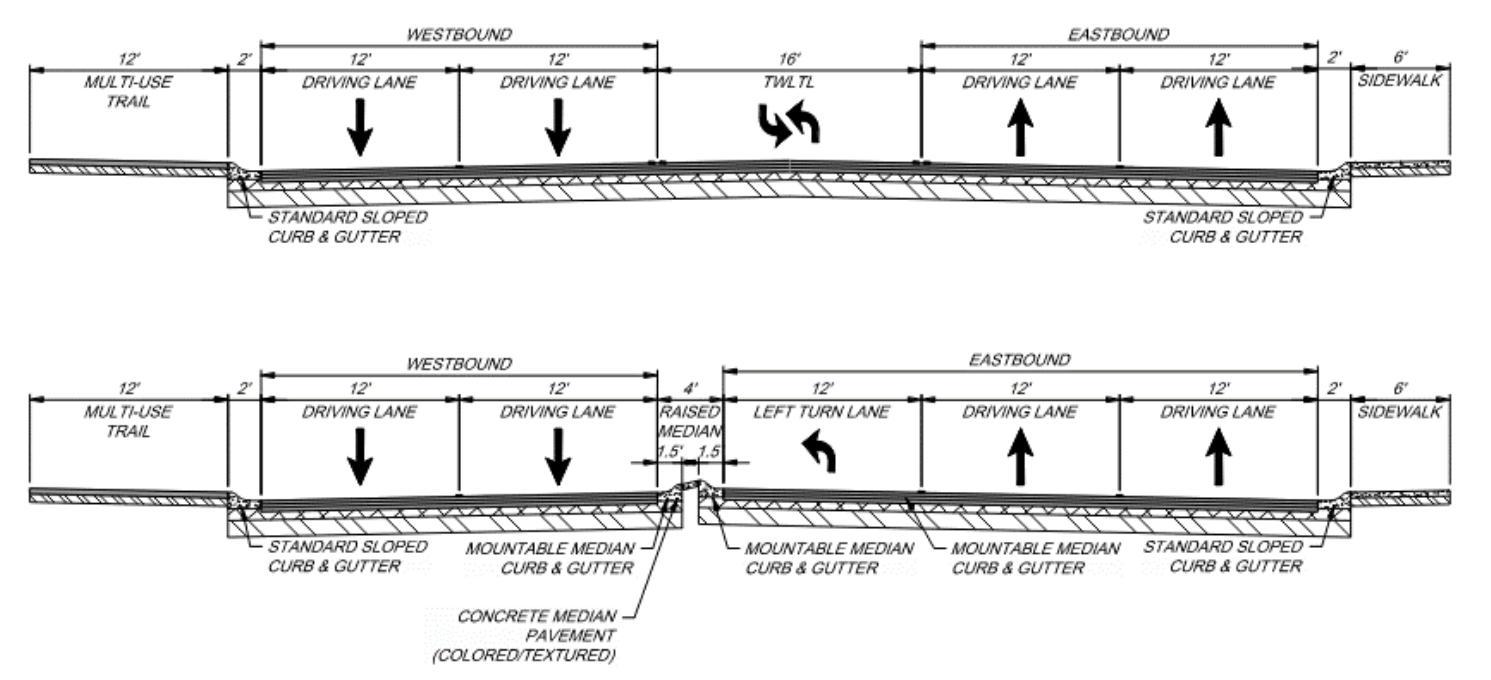
Figure 67. Urban Alternative 5 Typical Section

Urban Alternative 5 includes reconstruction of the full 4-lane roadway section. The newly constructed section would include two 12-foot driving lanes in each direction and a 16-foot TWLTL (Figure 67). There would be mountable curb and gutter on the outside of the section in each direction with a 6-foot sidewalk in one direction and a 12-foot multi-use trail in the other direction. Other improvements include updated signs and striping with left-turn lanes provided to adjacent properties.

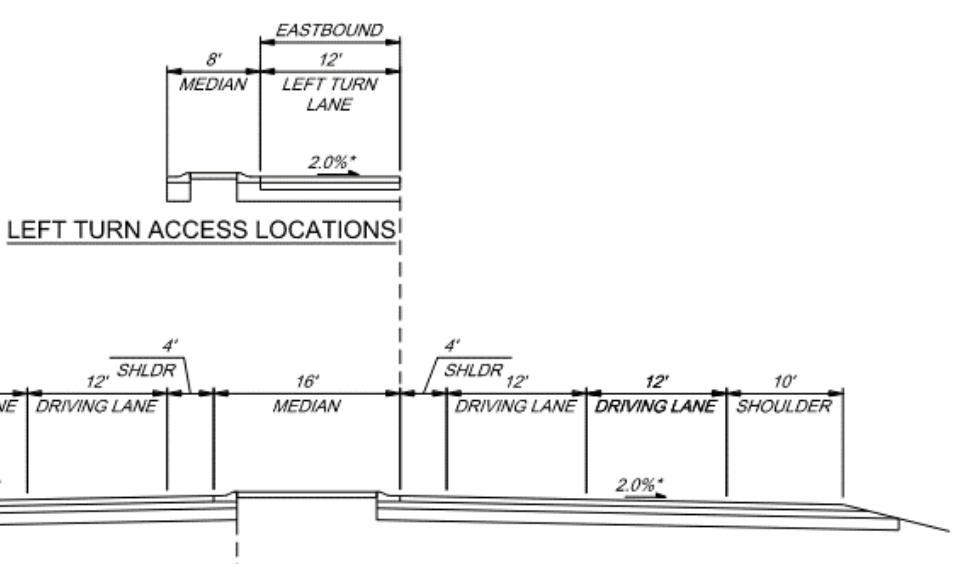
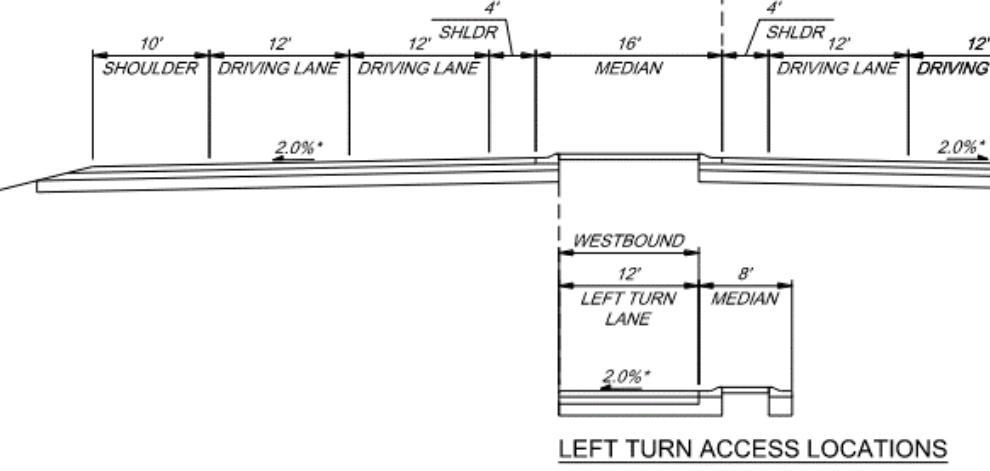
Figure 70. Rural Alternative 1 Existing Typical Section

The No-Build Alternative would make no improvements to the NM 264 rural section. The existing typical section (Figure 70), lane configuration, median details, pedestrian facilities can be found under the Section 1.3, Existing Conditions, of this report. See the TNA (Appendix B) for existing traffic safety and operation.

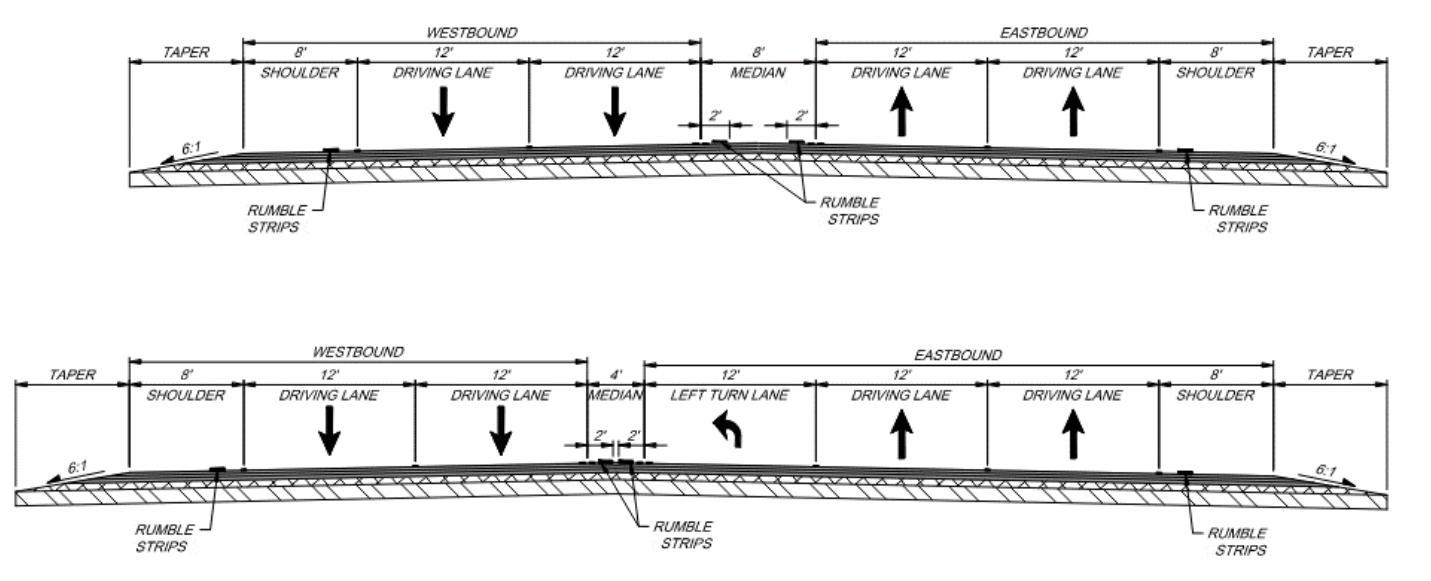
Figure 73. Rural Alternative 4 Typical Section

Rural Alternative 4 includes reconstruction of the full 4-lane roadway section. The newly constructed section would include two 12-foot driving lanes in each direction, an unraised 8-foot median, and an 8-foot outside shoulder in each direction (Figure 73). No pedestrian facilities would be included. Other improvements include updated signs and striping with left-turn lanes provided to adjacent properties.

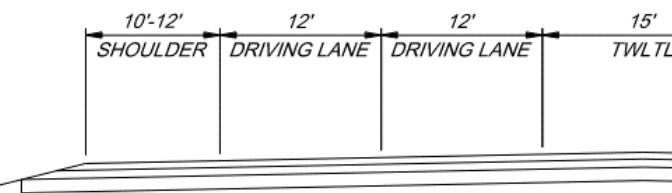
Figure 75. Urban/Rural Alternative 1 Existing Typical Section

The No-Build Alternative would make no improvements to the NM 264 urban/rural section. The existing typical section (Figure 75), lane configuration, median details, and pedestrian facilities can be found in Section 1.3, Existing Conditions, of this report. See the TNA (Appendix B) for existing traffic safety and operation.

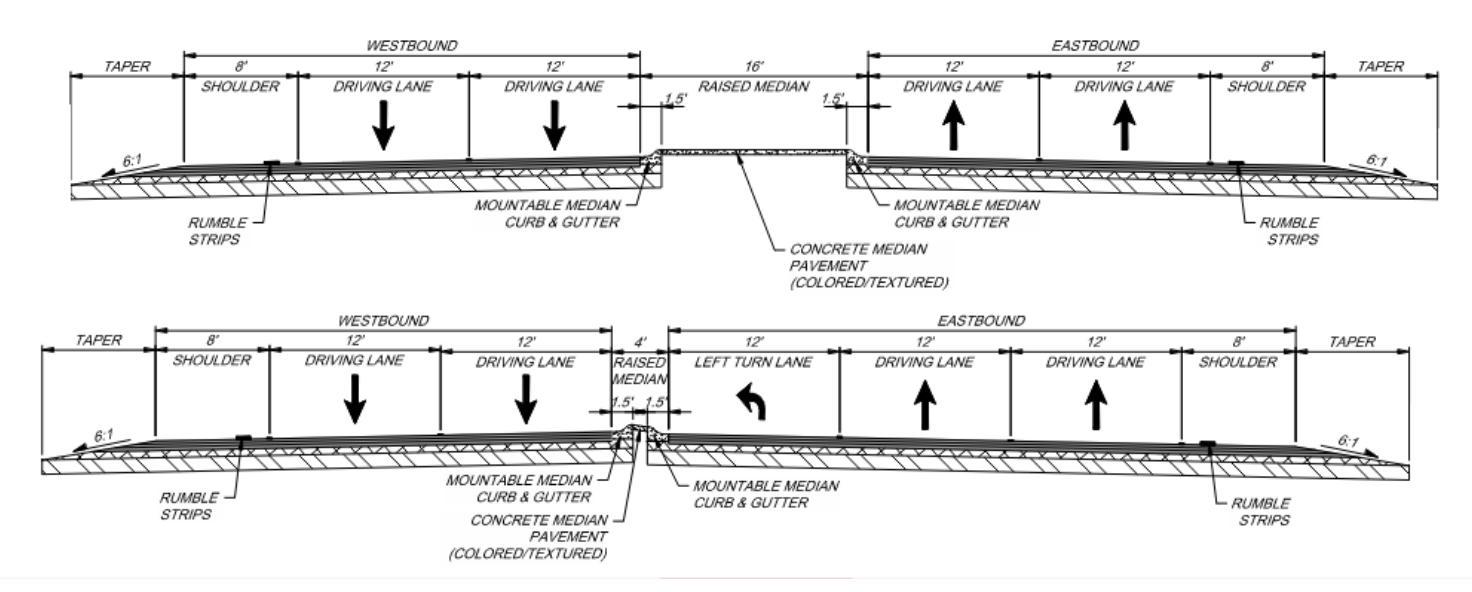
Figure 76. Urban/Rural Alternative 2 Typical Section

Urban/Rural Alternative 2 includes reconstruction of the full 4-lane roadway section. The newly constructed section would include two 12-foot driving lanes in each direction, a raised 16-foot mountable curb median, and 8-foot outside shoulders in each direction (Figure 76). Other improvements include updated signs and striping with left-turn lanes provided to adjacent properties.

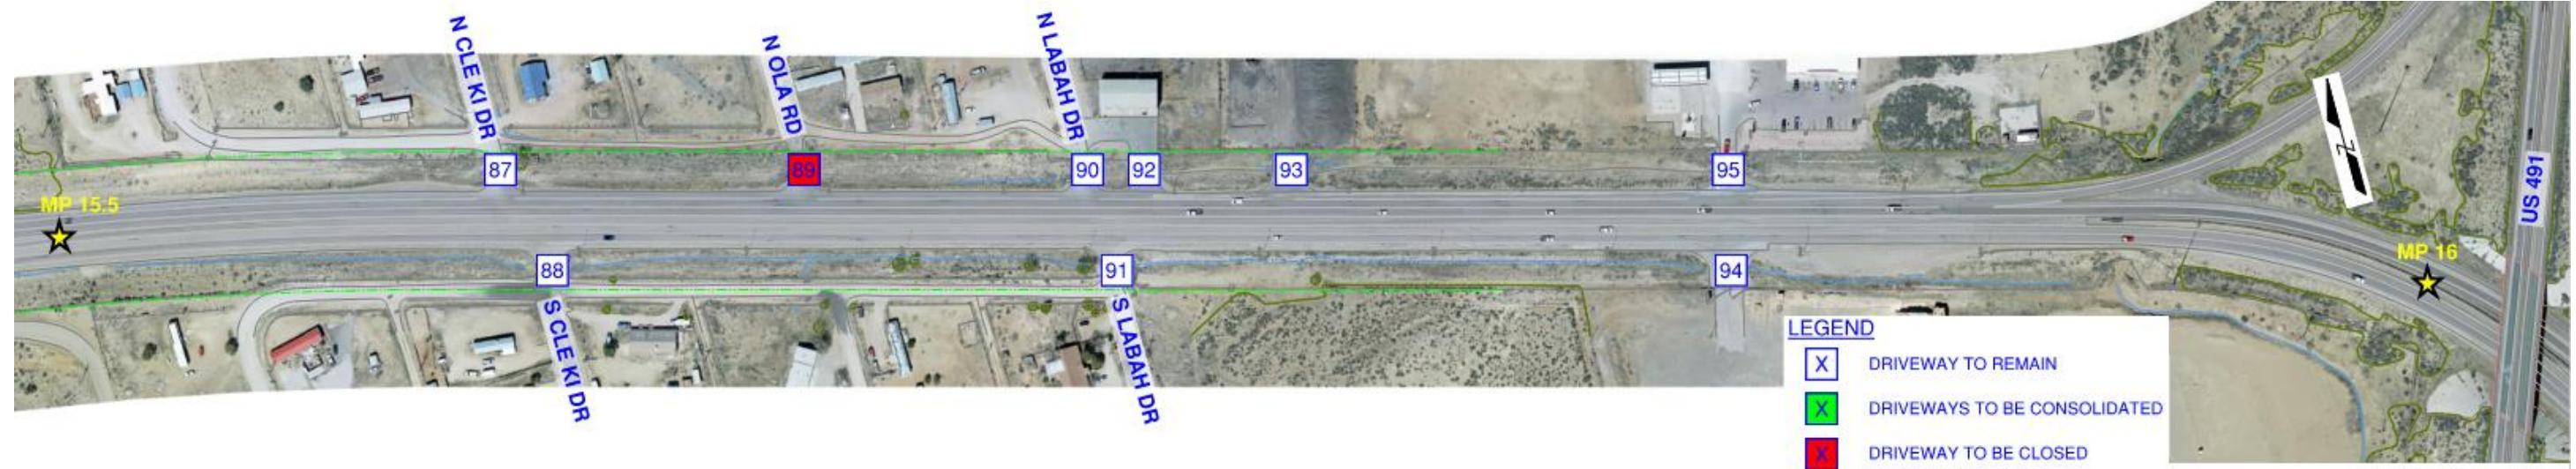
Figure 77. Segment 3 Access Management

Urban/Rural Alternative 2 would implement access management for the urban/rural section. Existing left-turn lanes would be extended to meet the SAMM requirements and auxiliary lanes would be implemented where warranted (Figure 77).
